## **Access Compliance Report Public Rights-of-Way** (Curb Ramps)

Intersection ID: 28840 Main Street: FAIRGLEN\_RD **Cross Street: HEWITT\_DR** Location: SW **ADA ID: 62A6B98E7CD9** Ramp Type: Perp Initial Pass/Fail: Fail **Overall Compliance: No Severity Score:** 15

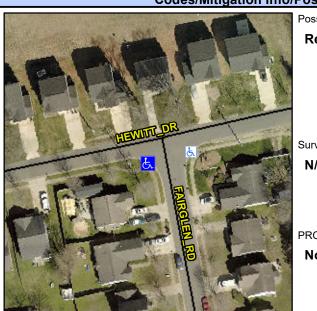
Poor

No

Surface Condition? (G/P)

/Possible Solution		Field Measurements/Component Compliance							
Possible Solutions:		Compl	iance Description	Data	Compliand	e Description	Data		
Remove & Replace Entire	Ramp.	N/A	Ramp Length (in)	71.0	Yes Ra	mp Slope (%)	6.6
