## Access Compliance Report Public Rights-of-Way (Curb Ramps)

Intersection ID: 44069Main Street:WESTMILL\_LNCross Street:KIRKWICH\_CTLocation:NADA ID: 62A85050E444Ramp Type:PerpDiagInitial Pass/Fail:FailOverall Compliance:NoSeverity Score:35

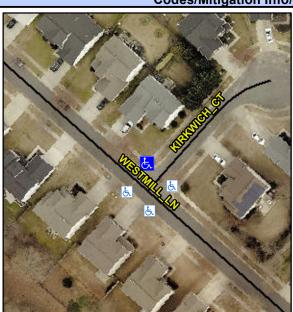
Not Found, R304.5.1

Compliance Description		Data	Compli	ance Description	n Data
N/A	Ramp Length (in)	72.0	Yes	Ramp Slope (%)	7.7
No	Ramp Width (in)	28.5	Yes	Ramp XSlope (%)	0.4
N/A	Flare Type LT	N/A	N/A	Flare Type RT	N/A
N/A	Flare Slope LT (%)	N/A	N/A	Flare Slope RT (%	(6) N/A
N/A	Flare Traversable LT?	N/A	N/A	Flare Traversable	RT? N/A
N/A	Landing Length (in)	N/A	N/A	DWS Provided?	N/A
N/A	Landing Width (in)	N/A	N/A	DWS Contrast?	N/A
N/A	Landing Slope (%)	N/A	N/A	DWS Length (in)	N/A
N/A	Landing X Slope (%)	N/A	N/A	DWS Full Width?	N/A
N/A	Landing Curb? (Y/N)	N/A	N/A	DWS Offset (in)	N/A
N/A	Shared Landing?	N/A			
N/A	Gutter Ponding?	N/A	N/A	Gutter Slope (%)	N/A
N/A	Gutter Lip Ht (in)	N/A	N/A	Gutter X Slope (%	) N/A
N/A	Painted X Walk1?	No	N/A	Painted X Walk2?	No
	X Walk 1 Direction	To SW		X Walk 2 Direction	n To SE
N/A	X Walk 1 Width (in)	N/A	N/A	X Walk 2 Width (in	n) <b>N/</b>
	X Walk 1 Slope (%)	0.0		X Walk 2 Slope (%	6) <b>0.</b> 3

X Walk 1 X Slope (%)	0.3		X Walk 2 X Slope	(%) 0.4
N/A	Ramp inside XWalk1?	N/A	N/A	Ramp inside XWa	lk2? <b>N/</b>
	Road Slope (%)	0.3	N/A	Clear Space?	N/A
	Road X Slope (%)	0.6	N/A	Clear Space to XV	Walk (in) N/A
N/A	Any Obstructions?	N/A	N/A	Storm Grate/Utility	y Hazard? N/A
	Obstruction Type			Storm Grate/Utility	у Туре
		N/A			N/A

Remove & Replace Curb Ramp With Two New Directional Ramps or Equivalent.

Total Cost: \$ 3200.00
