# Access Compliance Report

## Public Rights-of-Way

### (Curb Ramps)

Intersection ID: 10014519	Main Street: UNIVERSITY_POINTE_BV	Cross Street: N/A	Location: NE
ADA ID: 62AD017CEE6A	Ramp Type: Perp	Initial Pass/Fail: Fail	Overall Compliance: No
Severity Score: 21.25			
Codes/Mitigation Info/Possible Solution		Field Measurements/Component Compliance

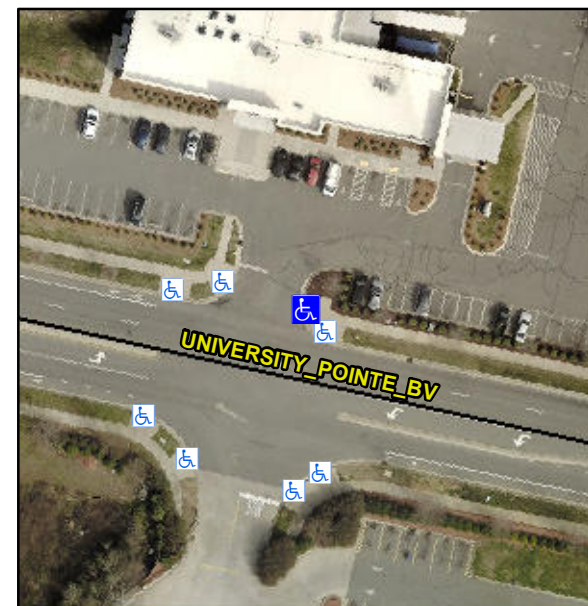
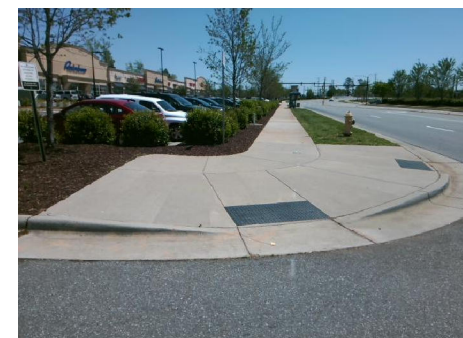
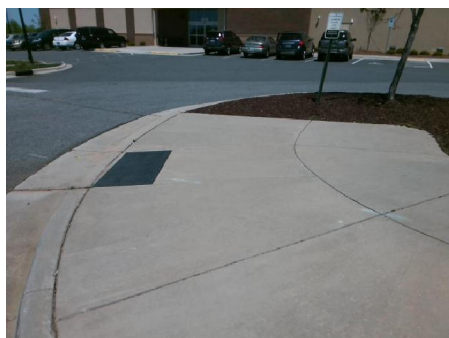
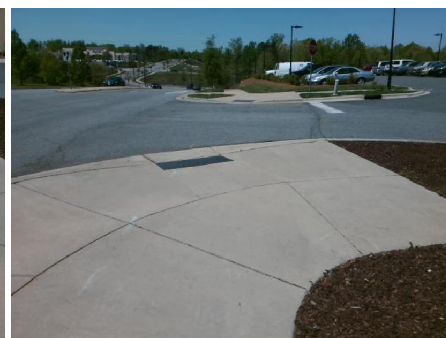
**Not Found, R304.5.1, R304.2.2**

Compliance	Description	Data	Compliance	Description	Data
N/A	Ramp Length (in)	91.0	No	Ramp Slope (%)	9.0
No	Ramp Width (in)	47.0	Yes	Ramp XSlope (%)	1.1
N/A	Flare Type LT	N/A	N/A	Flare Type RT	N/A
N/A	Flare Slope LT (%)	N/A	N/A	Flare Slope RT (%)	N/A
N/A	Flare Traversable LT?	N/A	N/A	Flare Traversable RT?	N/A
N/A	Landing Length (in)	N/A	N/A	DWS Provided?	N/A
N/A	Landing Width (in)	N/A	N/A	DWS Contrast?	N/A
N/A	Landing Slope (%)	N/A	N/A	DWS Length (in)	N/A
N/A	Landing X Slope (%)	N/A	N/A	DWS Full Width?	N/A
N/A	Landing Curb? (Y/N)	N/A	N/A	DWS Offset (in)	N/A
N/A	Shared Landing?	N/A			
N/A	Gutter Ponding?	N/A	N/A	Gutter Slope (%)	N/A
N/A	Gutter Lip Ht (in)	N/A	N/A	Gutter X Slope (%)	N/A
N/A	Painted X Walk1?	No	N/A	Painted X Walk2?	N/A
	X Walk 1 Direction	To W		X Walk 2 Direction	N/A
N/A	X Walk 1 Width (in)	N/A	N/A	X Walk 2 Width (in)	N/A
	X Walk 1 Slope (%)	3.3		X Walk 2 Slope (%)	N/A
	X Walk 1 X Slope (%)	2.6		X Walk 2 X Slope (%)	N/A

N/A	Ramp inside XWalk1?	N/A	N/A	Ramp inside XWalk2?	N/A
	Road Slope (%)	N/A	N/A	Clear Space?	N/A
	Road X Slope (%)	N/A	N/A	Clear Space to XWalk (in)	N/A
N/A	Any Obstructions?	N/A	N/A	Storm Grate/Utility Hazard?	N/A
	Obstruction Type			Storm Grate/Utility Type	
		N/A			N/A
			Yes	Surface Condition? (G/P)	Good

Possible Solutions:

**Remove & Replace Entire Ramp.**
