Access Compliance Report

Public Rights-of-Way

(Curb Ramps)

Intersection ID: 6328	Main Street: E_W_T_HARRIS_RA	Cross Street: UNIVERSITY_CITY_BV	Location: NE
ADA ID: 62AFF89A7AA7	Ramp Type: Directional1	Initial Pass/Fail: Pass	Overall Compliance: No
Severity Score: 17.5			
Codes/Mitigation Info/Possible Solution		Field Measurements/Component Compliance

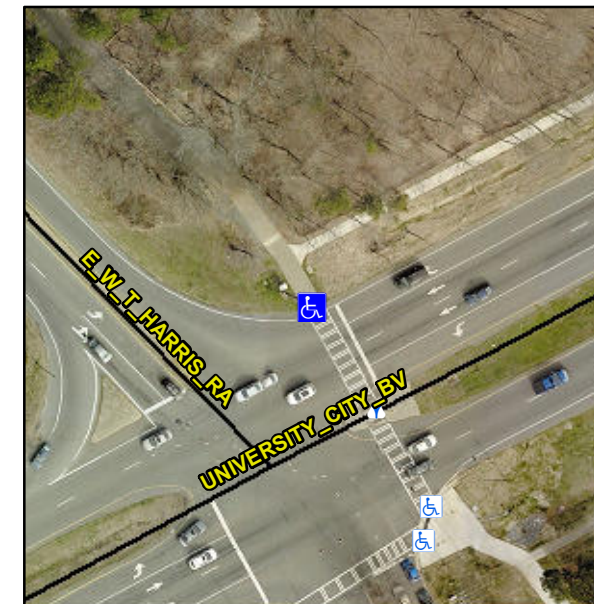
NO CURB

**R304.2.2-Perp, R304.3.2-Para,
R305.1.4, R305.2, R302.7, R302.7.2**

Compliance	Description	Data	Compliance	Description	Data
N/A	Ramp Length (in)	123.0	Yes	Grade Break?	Yes
Yes	Ramp Width (in)	120.0	Yes	Grade Break Slope (%)	2.3
Yes	Ramp Slope (%)	5.2	Yes	Grade Break XSlope (%)	2.6
Yes	Ramp XSlope (%)	1.1			
N/A	Flare Type LT	N/A	N/A	Flare Type RT	N/A
N/A	Flare Slope LT (%)	N/A	N/A	Flare Slope RT (%)	N/A
N/A	Flare Traversable LT?	N/A	N/A	Flare Traversable RT?	N/A
Yes	Landing Length (in)	120.0	Yes	DWS Provided?	Yes
Yes	Landing Width (in)	120.5	Yes	DWS Contrast?	Yes
No	Landing Slope (%)	4.0	Yes	DWS Length (in)	24.5
Yes	Landing X Slope (%)	0.8	No	DWS Full Width?	No
N/A	Landing Curb? (Y/N)	N/A	No	DWS Offset LT (in)	8.0
N/A	Shared Landing?	No	Yes	DWS Offset RT (in)	16.0
No	Gutter Ponding?	Yes	Yes	Gutter Slope (%)	0.0
No	Gutter Lip Ht (in)	0.8	Yes	Gutter X Slope (%)	0.0
N/A	Painted X Walk1?	Yes		Road Slope (%)	2.8
	X Walk 1 Direction	To S		Road X Slope (%)	3.0
	X Walk 1 Width (in)	109.0		Clear Space?	Yes

X Walk 1 Slope (%)	2.8	N/A	Clear Space to XWalk (in)	N/A
	X Walk 1 X Slope (%)	3.0	Yes	Storm Grate/Utility Hazard?	No
Yes	Ramp inside XWalk1?	Yes		Storm Grate/Utility Type	
Yes	Any Obstructions?	No			N/A
	Obstruction Type		Yes	Surface Condition? (G/P)	Good
			N/A	Curb Slope (%)	N/A

**Remove & Replace Entire Ramp.
Grind Gutter Lip.**
