Access Compliance Report Public Rights-of-Way (Curb Ramps)

Intersection ID: 9641	Main Street: CONDON_ST	Cross Street: PATTON_AV	Location: SW
ADA ID: 62B20B01B701	Ramp Type: Directional1	Initial Pass/Fail: Fail	Overall Compliance: No Severity Score: 12.5

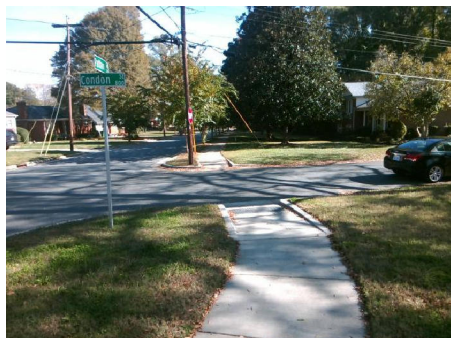
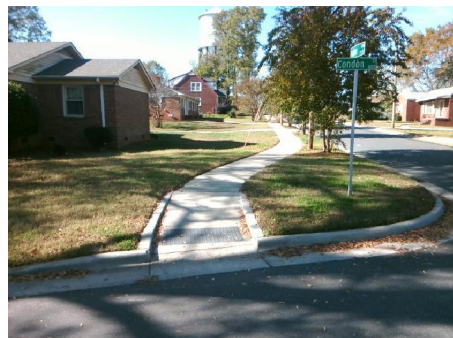
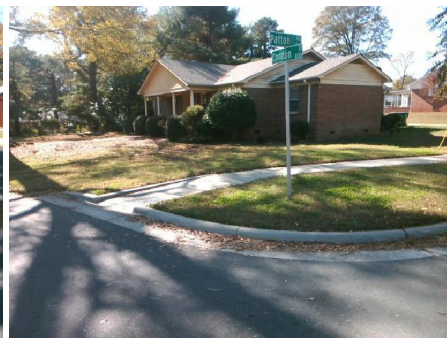
Compliance	Description	Data	Compliance	Description	Data
N/A	Ramp Length (in)	113.0	N/A	Grade Break?	N/A
Yes	Ramp Width (in)	59.0	N/A	Grade Break Slope (%)	0.0
No	Ramp Slope (%)	9.3	N/A	Grade Break XSlope (%)	0.0
Yes	Ramp XSlope (%)	0.2			
N/A	Flare Type LT	N/A	N/A	Flare Type RT	N/A
N/A	Flare Slope LT (%)	N/A	N/A	Flare Slope RT (%)	0.0
N/A	Flare Traversable LT?	N/A	N/A	Flare Traversable RT?	N/A
N/A	Landing Length (in)	0.0	N/A	DWS Provided?	N/A
N/A	Landing Width (in)	0.0	N/A	DWS Contrast?	N/A
N/A	Landing Slope (%)	0.0	N/A	DWS Length (in)	N/A
N/A	Landing X Slope (%)	0.0	N/A	DWS Full Width?	N/A
N/A	Landing Curb? (Y/N)	N/A	N/A	DWS Offset LT (in)	N/A
N/A	Shared Landing?	N/A	N/A	DWS Offset RT (in)	N/A
N/A	Gutter Ponding?	0.0	N/A	Gutter Slope (%)	N/A
N/A	Gutter Lip Ht (in)	0.0	N/A	Gutter X Slope (%)	N/A
N/A	Painted X Walk1?	No		Road Slope (%)	1.4
	X Walk 1 Direction	To E		Road X Slope (%)	1.3
	X Walk 1 Width (in)	N/A		Clear Space?	N/A

X Walk 1 Slope (%)	1.4	N/A	Clear Space to XWalk (in)	N/A
	X Walk 1 X Slope (%)	1.3	N/A	Storm Grate/Utility Hazard?	N/A
N/A	Ramp inside XWalk1?	N/A		Storm Grate/Utility Type	
N/A	Any Obstructions?	N/A			N/A
	Obstruction Type		Yes	Surface Condition? (G/P)	Good
			N/A	Curb Slope (%)	19.5

Remove & Replace Entire Ramp.
