Access Compliance Report

Public Rights-of-Way

(Curb Ramps)

Intersection ID: 8626	Main Street: TRYON ST	Cross Street: NORTHCHASE DR	Location: S
ADA ID: 62B7AED7C6AF	Ramp Type: BlendTrans1	Initial Pass/Fail: Fail	Overall Compliance: No
		Severity Score: 15

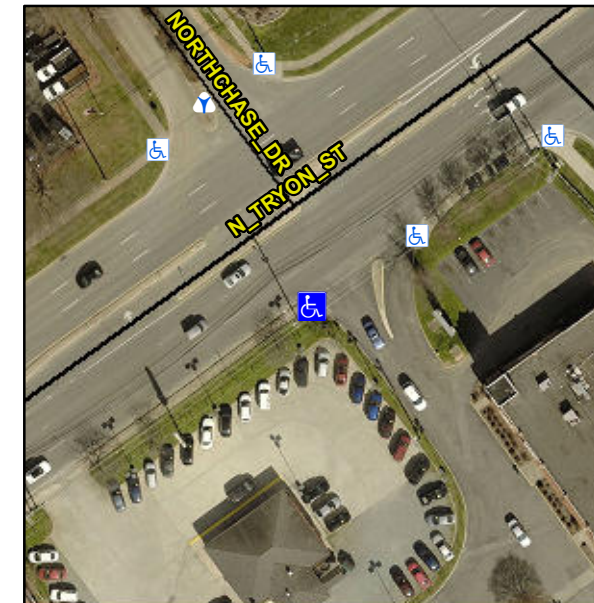
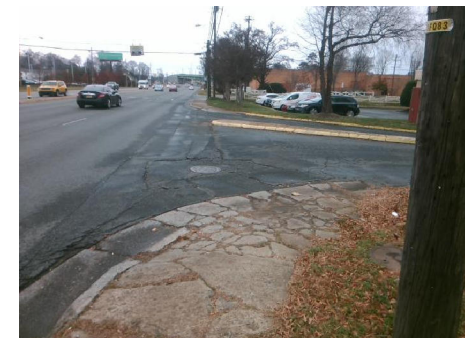
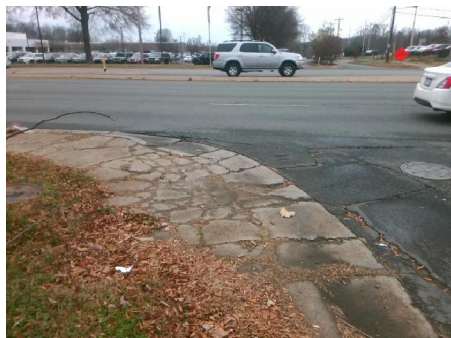
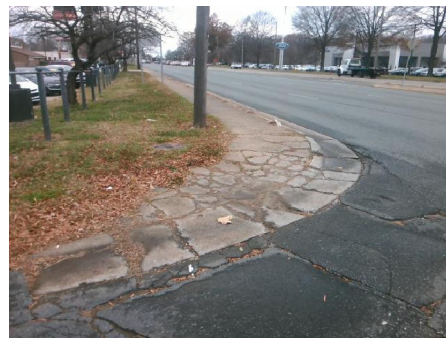
MEDIAN ACROSS TRYON ST

Compliance	Description	Data	Compliance	Description	Data
N/A	Ramp Length (in)	60.0	Yes	BlendTrans Slope (%)	3.8
Yes	Ramp Width (in)	108.0	Yes	BlendTrans XSlope (%)	2.0
N/A	Flare Type LT	N/A	N/A	Flare Type RT	N/A
N/A	Flare Slope LT (%)	N/A	N/A	Flare Slope RT (%)	N/A
N/A	Flare Traversable LT?	No	N/A	Flare Traversable RT?	No
N/A	Landing Length (in)	N/A	N/A	DWS Provided?	N/A
N/A	Landing Width (in)	N/A	N/A	DWS Contrast?	N/A
N/A	Landing Slope (%)	N/A	N/A	DWS Length (in)	N/A
N/A	Landing X Slope (%)	N/A	N/A	DWS Full Width?	N/A
N/A	Landing Curb? (Y/N)	N/A	N/A	DWS Offset (in)	N/A
N/A	Shared Landing?	N/A			
N/A	Gutter Ponding?	N/A	N/A	Gutter Slope (%)	N/A
N/A	Gutter Lip Ht (in)	N/A	N/A	Gutter X Slope (%)	N/A
N/A	Painted X Walk1?	No	N/A	Painted X Walk2?	No
	X Walk 1 Direction	To NE		X Walk 2 Direction	To NW
	X Walk 1 Width (in)	N/A		X Walk 2 Width (in)	N/A
	X Walk 1 Slope (%)	0.8		X Walk 2 Slope (%)	1.1
	X Walk 1 X Slope (%)	1.7		X Walk 2 X Slope (%)	0.5

N/A	Ramp inside XWalk1?	N/A	N/A	Ramp inside XWalk2?	N/A
	Road Slope (%)	0.0		Clear Space?	N/A
	Road X Slope (%)	1.9	N/A	Clear Space to XWalk (in)	N/A
N/A	Any Obstructions?	N/A	N/A	Storm Grate/Utility Hazard?	N/A
	Obstruction Type			Storm Grate/Utility Type	
		N/A			N/A
			No	Surface Condition? (G/P)	Poor
			Yes	Curb Slope (%)	0.6

Remove & Replace Curb Ramp With Two New Directional Ramps or Equivalent.

R302.7
