Access Compliance Report

Public Rights-of-Way

(Curb Ramps)

Intersection ID: 9295		Main Street: MILES_CT		Cross Street: ORVIS_ST		Location: NE			
ADA ID: 62CDB15DF6C1		Ramp Type: BlendTrans1		Initial Pass/Fail: Fail		Overall Compliance: No		Severity Score: 10	
Codes/Mitigation Info/Possible Solution				Field Measurements/Component Compliance

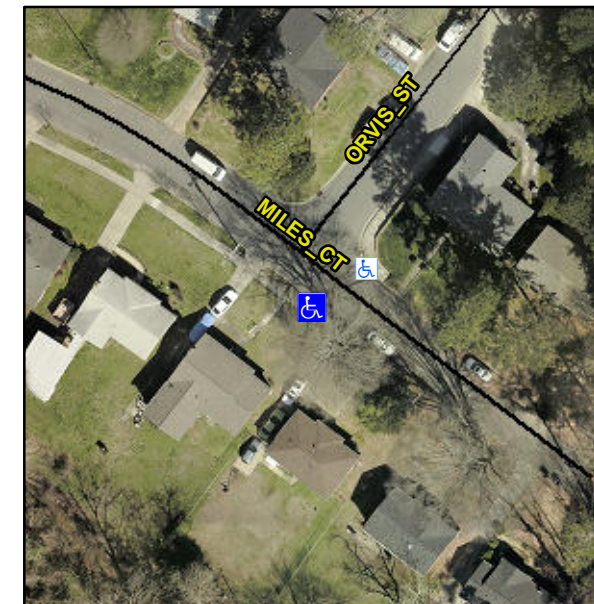
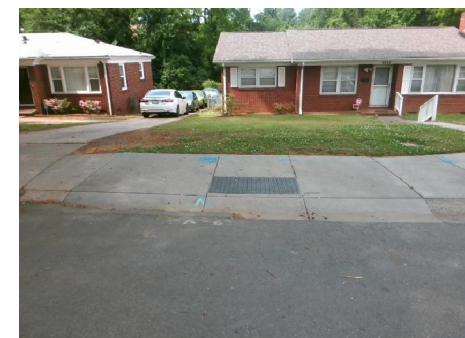
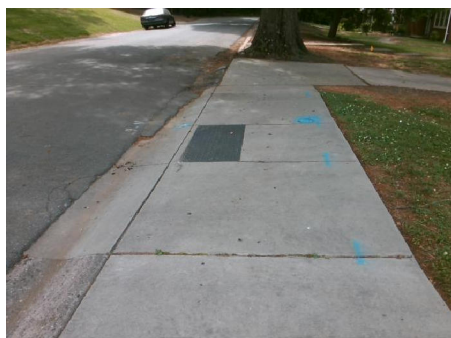
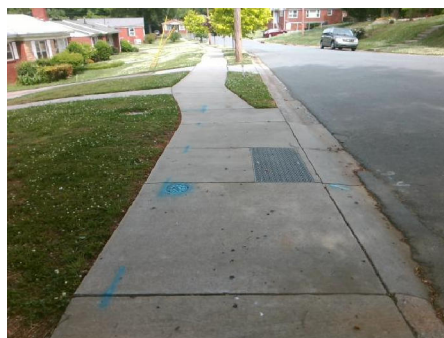
Not Found, R304.5.1, R304.5.3

Compliance	Description	Data	Compliance	Description	Data
N/A	Ramp Length (in)	72.0	Yes	BlendTrans Slope (%)	2.4
No	Ramp Width (in)	47.0	No	BlendTrans XSlope (%)	2.5
N/A	Flare Type LT	N/A	N/A	Flare Type RT	N/A
N/A	Flare Slope LT (%)	N/A	N/A	Flare Slope RT (%)	N/A
N/A	Flare Traversable LT?	N/A	N/A	Flare Traversable RT?	N/A
N/A	Landing Length (in)	N/A	N/A	DWS Provided?	N/A
N/A	Landing Width (in)	N/A	N/A	DWS Contrast?	N/A
N/A	Landing Slope (%)	N/A	N/A	DWS Length (in)	N/A
N/A	Landing X Slope (%)	N/A	N/A	DWS Full Width?	N/A
N/A	Landing Curb? (Y/N)	N/A	N/A	DWS Offset (in)	N/A
N/A	Shared Landing?	N/A			
N/A	Gutter Ponding?	N/A	N/A	Gutter Slope (%)	N/A
N/A	Gutter Lip Ht (in)	N/A	N/A	Gutter X Slope (%)	N/A
N/A	Painted X Walk1?	No	N/A	Painted X Walk2?	N/A
	X Walk 1 Direction	To S		X Walk 2 Direction	N/A
	X Walk 1 Width (in)	N/A		X Walk 2 Width (in)	N/A
	X Walk 1 Slope (%)	6.9		X Walk 2 Slope (%)	N/A
	X Walk 1 X Slope (%)	1.1		X Walk 2 X Slope (%)	N/A

N/A	Ramp inside XWalk1?	N/A	N/A	Ramp inside XWalk2?	N/A
	Road Slope (%)	1.1		Clear Space?	N/A
	Road X Slope (%)	6.9	N/A	Clear Space to XWalk (in)	N/A
N/A	Any Obstructions?	N/A	N/A	Storm Grate/Utility Hazard?	N/A
	Obstruction Type			Storm Grate/Utility Type	
		N/A			N/A
			Yes	Surface Condition? (G/P)	Good
			No	Curb Slope (%)	7.2

Possible Solutions:

Remove & Replace Curb Ramp With Two New Directional Ramps or Equivalent.
