Access Compliance Report Public Rights-of-Way (Curb Ramps)

Intersection ID: N/A Main Street: BOYCE_RD Cross Street: TOBIN_CT Location: NW

ADA ID: 62D0DC75D015 Ramp Type: Directional1 Initial Pass/Fail: Fail Overall Compliance: No Severity Score: 46.25

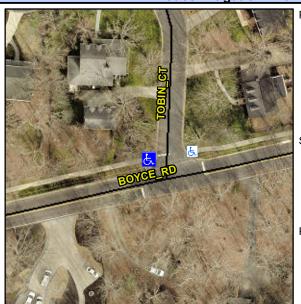
•	No	Ramp Width (in)	47.0	N/A	Grade Break Slope (%)	0.0	
	No	Ramp Slope (%)	8.9	N/A	Grade Break XSlope (%)	0.0	
	No	Ramp XSlope (%)	7.0				
	N/A	Flare Type LT	N/A	N/A	Flare Type RT	N/A	
A CONTRACTOR OF THE CONTRACTOR	N/A	Flare Slope LT (%)	N/A	N/A	Flare Slope RT (%)	0.0	
Surveyor Notes:	N/A	Flare Traversable LT?	N/A	N/A	Flare Traversable RT?	N/A	
N/A	N/A	Landing Length (in)	0.0	N/A	DWS Provided?	N/A	
	N/A	Landing Width (in)	0.0	N/A	DWS Contrast?	N/A	
	N/A	Landing Slope (%)	0.0	N/A	DWS Length (in)	N/A	
	N/A	Landing X Slope (%)	0.0	N/A	DWS Full Width?	N/A	
PROW/ADA:	N/A	Landing Curb? (Y/N)	N/A	N/A	DWS Offset LT (in)	N/A	
R304.5.1, R304.2.2, R304.5.3	N/A	Shared Landing?	N/A	N/A	DWS Offset RT (in)	N/A	
,	N/A	Gutter Ponding?	0.0	N/A	Gutter Slope (%)	N/A	
	N/A	Gutter Lip Ht (in)	0.0	N/A	Gutter X Slope (%)	N/A	
	N/A	Painted X Walk1?	No		Road Slope (%)	5.2	
		X Walk 1 Direction	To E		Road X Slope (%)	4.3	
		X Walk 1 Width (in)	N/A		Clear Space?	N/A

X Walk 1 Slope (%)	5.2	N/A	Clear Space to XWalk (in)	N/A	
		X Walk 1 X Slope (%)	4.3	N/A	Storm Grate/Utility Hazard?	N/A	
	N/A	Ramp inside XWalk1?	N/A		Storm Grate/Utility Type		
	N/A	Any Obstructions?	N/A			N/A	
Total Cost: \$ 1600.00		Obstruction Type		Yes	Surface Condition? (G/P)	Good	
			N/A	N/A	Curb Slope (%)	2.3

o/Possible Solution		Field Measurements/Component Compliance					
Possible Solutions:	Com	pliance Description	Data	Comp	liance Description	Data	
Remove & Replace Entire Ramp.	N/A	Ramp Length (in)	74.0	N/A	Grade Break?	N/A
