Access Compliance Report

Public Rights-of-Way

(Curb Ramps)

Intersection ID: 12269	Main Street: E_10TH_ST	Cross Street: N_DAVIDSON_ST	Location: W
ADA ID: 62D89FB47C7A	Ramp Type: Perp	Initial Pass/Fail: Fail	Overall Compliance: No
Severity Score: 12.5			
Codes/Mitigation Info/Possible Solution		Field Measurements/Component Compliance

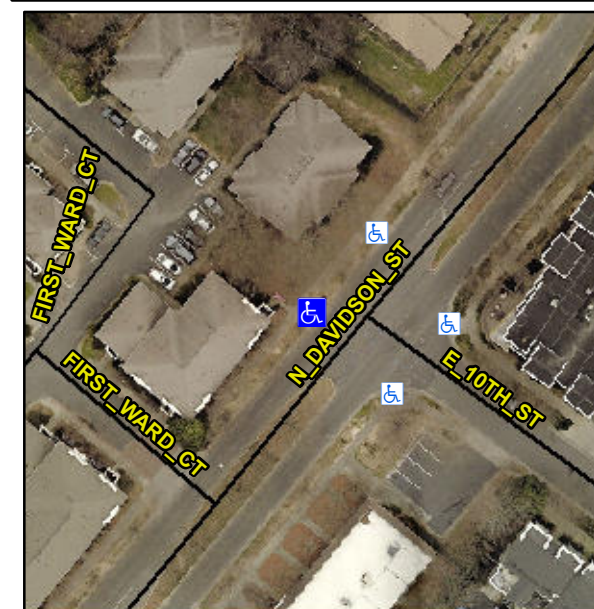
Not Found, R304.2.2

Compliance	Description	Data	Compliance	Description	Data
N/A	Ramp Length (in)	80.0	No	Ramp Slope (%)	9.1
Yes	Ramp Width (in)	48.0	Yes	Ramp XSlope (%)	0.9
N/A	Flare Type LT	N/A	N/A	Flare Type RT	N/A
N/A	Flare Slope LT (%)	N/A	N/A	Flare Slope RT (%)	N/A
N/A	Flare Traversable LT?	N/A	N/A	Flare Traversable RT?	N/A
N/A	Landing Length (in)	N/A	N/A	DWS Provided?	N/A
N/A	Landing Width (in)	N/A	N/A	DWS Contrast?	N/A
N/A	Landing Slope (%)	N/A	N/A	DWS Length (in)	N/A
N/A	Landing X Slope (%)	N/A	N/A	DWS Full Width?	N/A
N/A	Landing Curb? (Y/N)	N/A	N/A	DWS Offset (in)	N/A
N/A	Shared Landing?	N/A			
N/A	Gutter Ponding?	N/A	N/A	Gutter Slope (%)	N/A
N/A	Gutter Lip Ht (in)	N/A	N/A	Gutter X Slope (%)	N/A
N/A	Painted X Walk1?	No	N/A	Painted X Walk2?	N/A
	X Walk 1 Direction	To SE		X Walk 2 Direction	N/A
N/A	X Walk 1 Width (in)	N/A	N/A	X Walk 2 Width (in)	N/A
	X Walk 1 Slope (%)	3.5		X Walk 2 Slope (%)	N/A
	X Walk 1 X Slope (%)	1.7		X Walk 2 X Slope (%)	N/A

N/A	Ramp inside XWalk1?	N/A	N/A	Ramp inside XWalk2?	N/A
	Road Slope (%)	N/A	N/A	Clear Space?	N/A
	Road X Slope (%)	N/A	N/A	Clear Space to XWalk (in)	N/A
N/A	Any Obstructions?	N/A	N/A	Storm Grate/Utility Hazard?	N/A
	Obstruction Type			Storm Grate/Utility Type	
		N/A			N/A
			Yes	Surface Condition? (G/P)	Good

Remove & Replace Entire Ramp.
