Access Compliance Report

Public Rights-of-Way

(Curb Ramps)

Intersection ID: 29647	Main Street: BALLYSHANNON LN	Cross Street: SOUTHERN GARDEN LN	Location: NW
ADA ID: 62DBE517F9DA	Ramp Type: PerpDiag	Initial Pass/Fail: Fail	Overall Compliance: No
Severity Score: 8.75			
Codes/Mitigation Info/Possible Solution		Field Measurements/Component Compliance

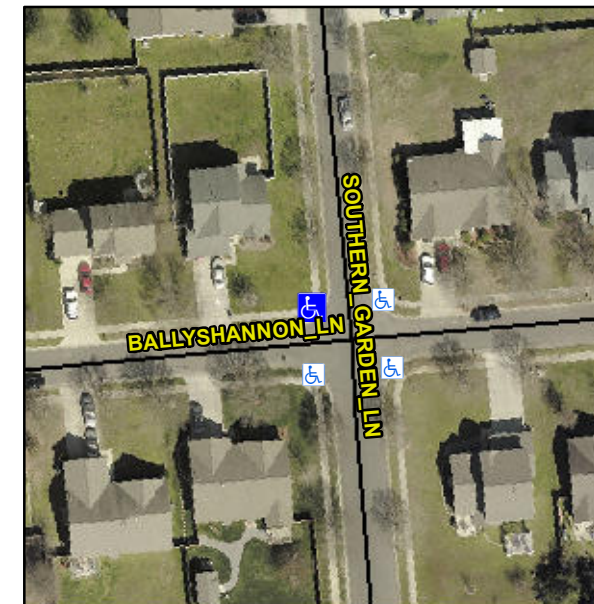
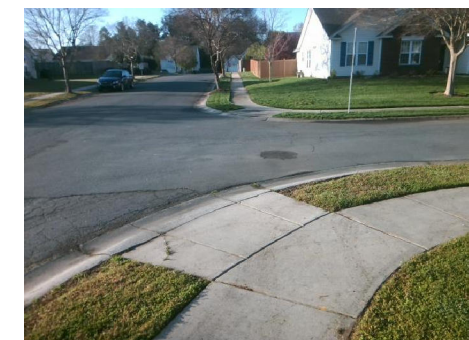
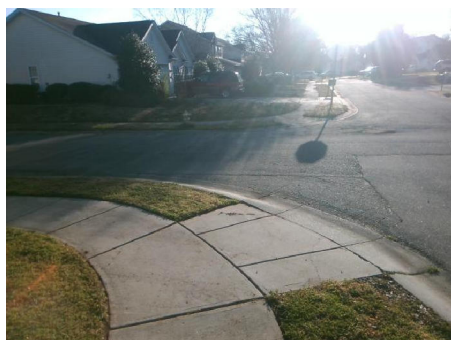
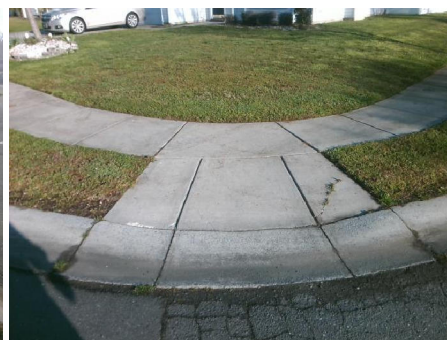
Not Found, R304.5.1

Compliance	Description	Data	Compliance	Description	Data
N/A	Ramp Length (in)	51.5	Yes	Ramp Slope (%)	6.3
No	Ramp Width (in)	36.3	Yes	Ramp XSlope (%)	2.0
N/A	Flare Type LT	N/A	N/A	Flare Type RT	N/A
N/A	Flare Slope LT (%)	N/A	N/A	Flare Slope RT (%)	N/A
N/A	Flare Traversable LT?	N/A	N/A	Flare Traversable RT?	N/A
N/A	Landing Length (in)	N/A	N/A	DWS Provided?	N/A
N/A	Landing Width (in)	N/A	N/A	DWS Contrast?	N/A
N/A	Landing Slope (%)	N/A	N/A	DWS Length (in)	N/A
N/A	Landing X Slope (%)	N/A	N/A	DWS Full Width?	N/A
N/A	Landing Curb? (Y/N)	N/A	N/A	DWS Offset (in)	N/A
N/A	Shared Landing?	N/A			
N/A	Gutter Ponding?	N/A	N/A	Gutter Slope (%)	N/A
N/A	Gutter Lip Ht (in)	N/A	N/A	Gutter X Slope (%)	N/A
N/A	Painted X Walk1?	No	N/A	Painted X Walk2?	No
	X Walk 1 Direction	To S		X Walk 2 Direction	To E
N/A	X Walk 1 Width (in)	N/A	N/A	X Walk 2 Width (in)	N/A
	X Walk 1 Slope (%)	1.4		X Walk 2 Slope (%)	0.6
	X Walk 1 X Slope (%)	0.5		X Walk 2 X Slope (%)	1.3

N/A	Ramp inside XWalk1?	N/A	N/A	Ramp inside XWalk2?	N/A
	Road Slope (%)	1.4	N/A	Clear Space?	N/A
	Road X Slope (%)	3.4	N/A	Clear Space to XWalk (in)	N/A
N/A	Any Obstructions?	N/A	N/A	Storm Grate/Utility Hazard?	N/A
	Obstruction Type			Storm Grate/Utility Type	
		N/A			N/A
		Yes		Surface Condition? (G/P)	Good

Remove & Replace Curb Ramp With Two New Directional Ramps or Equivalent.
