Access Compliance Report

Public Rights-of-Way

(Curb Ramps)

Intersection ID: N/A	Main Street: IDLEWILD_RD	Cross Street: N/A	Location: NE
ADA ID: 62DE383924C6	Ramp Type: Directional1	Initial Pass/Fail: Fail	Overall Compliance: No
Codes/Mitigation Info/Possible Solution		Field Measurements/Component Compliance	
Severity Score: 12.5

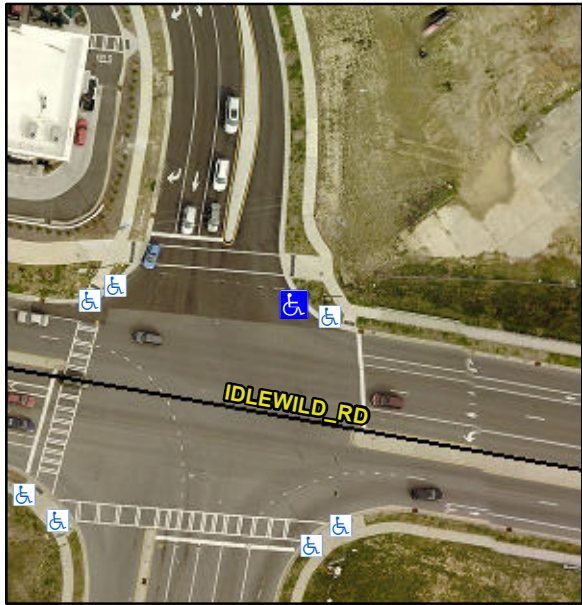
Compliance	Description	Data	Compliance	Description	Data
N/A	Ramp Length (in)	185.0	N/A	Grade Break?	N/A
Yes	Ramp Width (in)	135.0	N/A	Grade Break Slope (%)	0.0
Yes	Ramp Slope (%)	8.6	N/A	Grade Break XSlope (%)	0.0
Yes	Ramp XSlope (%)	0.5			
N/A	Flare Type LT	N/A	N/A	Flare Type RT	N/A
N/A	Flare Slope LT (%)	N/A	N/A	Flare Slope RT (%)	0.0
N/A	Flare Traversable LT?	N/A	N/A	Flare Traversable RT?	N/A
N/A	Landing Length (in)	0.0	N/A	DWS Provided?	N/A
N/A	Landing Width (in)	0.0	N/A	DWS Contrast?	N/A
N/A	Landing Slope (%)	0.0	N/A	DWS Length (in)	N/A
N/A	Landing X Slope (%)	0.0	N/A	DWS Full Width?	N/A
N/A	Landing Curb? (Y/N)	N/A	N/A	DWS Offset LT (in)	N/A
N/A	Shared Landing?	N/A	N/A	DWS Offset RT (in)	N/A
N/A	Gutter Ponding?	0.0	N/A	Gutter Slope (%)	N/A
N/A	Gutter Lip Ht (in)	0.0	N/A	Gutter X Slope (%)	N/A
N/A	Painted X Walk1?	No		Road Slope (%)	2.0
	X Walk 1 Direction	To W		Road X Slope (%)	4.9
	X Walk 1 Width (in)	N/A		Clear Space?	N/A

X Walk 1 Slope (%)	2.0	N/A	Clear Space to XWalk (in)	N/A
	X Walk 1 X Slope (%)	4.9	N/A	Storm Grate/Utility Hazard?	N/A
N/A	Ramp inside XWalk1?	N/A		Storm Grate/Utility Type	
N/A	Any Obstructions?	N/A			N/A
	Obstruction Type		Yes	Surface Condition? (G/P)	Good
		N/A	Yes	Curb Slope (%)	2.8

Possible Solutions:

Remove & Replace Entire Ramp.
