Access Compliance Report

Public Rights-of-Way

(Curb Ramps)

Intersection ID: 46810	Main Street: ARBOR_VISTA_DR	Cross Street: CLAUDE_FREEMAN_DR	Location:	N
ADA ID: 62FAE6F675FD	Ramp Type: Combination1	Initial Pass/Fail: Fail	Overall Compliance: No	Severity Score: 35

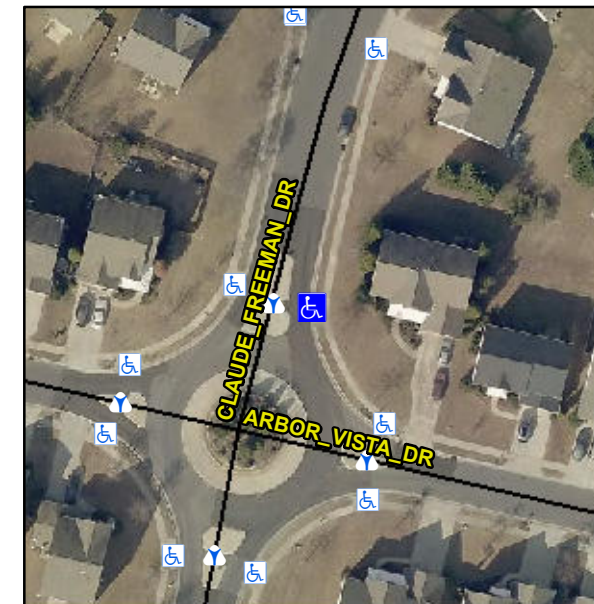
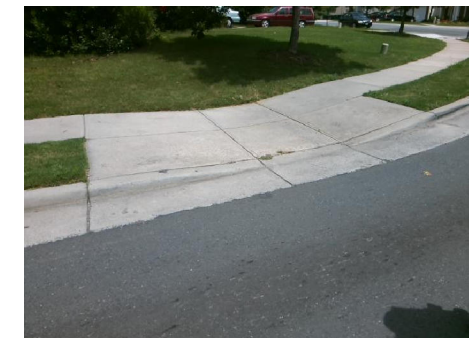
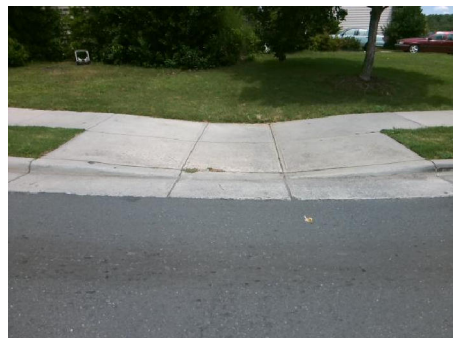
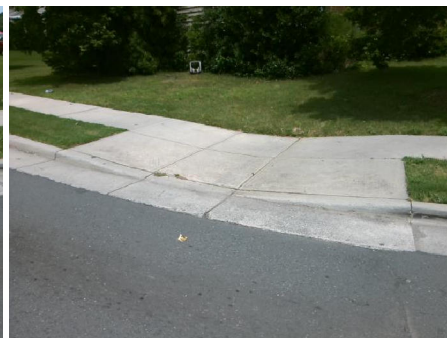
**R304.5.1, R304.5.1, R304.2.2,
R304.5.3**

Compliance	Description	Data	Compliance	Description	Data
N/A	Ramp Length LT (in)	69.0	N/A	Ramp Length RT (in)	65.0
No	Ramp Width LT (in)	47.5	Yes	Ramp Width RT (in)	48.0
Yes	Ramp Slope LT (%)	6.2	Yes	Ramp Slope RT (%)	7.2
Yes	Ramp XSlope LT (%)	0.3	Yes	Ramp XSlope RT (%)	1.9
N/A	Ramp Length (in)	46.0	No	Ramp Slope (%)	12.0
No	Ramp Width (in)	47.0	No	Ramp XSlope (%)	3.3
N/A	Flare Type LT	N/A	N/A	Flare Type RT	N/A
N/A	Flare Slope LT (%)	N/A	N/A	Flare Slope RT (%)	N/A
N/A	Flare Traversable LT?	N/A	N/A	Flare Traversable RT?	N/A
N/A	Landing Length (in)	N/A	N/A	DWS Provided?	N/A
N/A	Landing Width (in)	N/A	N/A	DWS Contrast?	N/A
N/A	Landing Slope (%)	N/A	N/A	DWS Length (in)	N/A
N/A	Landing X Slope (%)	N/A	N/A	DWS Full Width?	N/A
N/A	Landing Curb? (Y/N)	N/A	N/A	DWS Offset (in)	N/A
N/A	Shared Landing?	N/A			
N/A	Gutter Ponding?	N/A	N/A	Gutter Slope (%)	N/A
N/A	Gutter Lip Ht (in)	N/A	N/A	Gutter X Slope (%)	N/A
N/A	Painted X Walk1?	No	N/A	Painted X Walk2?	N/A

Remove & Replace Entire Ramp.
