## **Access Compliance Report Public Rights-of-Way** (Curb Ramps)

Main Street: CARLEEN WAY DR **Cross Street: GRIER SPRINGS LN** Location: Intersection ID: 31500 NW Ramp Type: PerpDiag Initial Pass/Fail: Fail **Overall Compliance: No** 22.5 ADA ID: 63008A504BCA **Severity Score:**

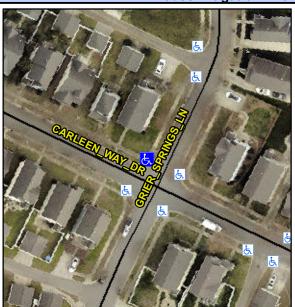
58.5 No

Not Found, R304.5.1, R304.2.2, R304.5.3

No	Ramp Width (in)	38.0	No	Ramp XSlope (%)
N/A	Flare Type LT	N/A	N/A	Flare Type RT
N/A	Flare Slope LT (%)	N/A	N/A	Flare Slope RT (%)
N/A	Flare Traversable LT?	N/A	N/A	Flare Traversable RT?
N/A	Landing Length (in)	N/A	N/A	DWS Provided?
N/A	Landing Width (in)	N/A	N/A	DWS Contrast?
N/A	Landing Slope (%)	N/A	N/A	DWS Length (in)
N/A	Landing X Slope (%)	N/A	N/A	DWS Full Width?
N/A	Landing Curb? (Y/N)	N/A	N/A	DWS Offset (in)
N/A	Shared Landing?	N/A		
N/A	Gutter Ponding?	N/A	N/A	Gutter Slope (%)
N/A	Gutter Lip Ht (in)	N/A	N/A	Gutter X Slope (%)
N/A	Painted X Walk1?	No	N/A	Painted X Walk2?
	X Walk 1 Direction	To SW		X Walk 2 Direction
N/A	X Walk 1 Width (in)	N/A	N/A	X Walk 2 Width (in)
	X Walk 1 Slope (%)	3.3		X Walk 2 Slope (%)
	X Walk 1 X Slope (%)	1.6		X Walk 2 X Slope (%)
N/A	Ramp inside XWalk1?	N/A	N/A	Ramp inside XWalk2?
	Road Slope (%)	4.0	N/A	Clear Space?
	Road X Slope (%)	0.6	N/A	Clear Space to XWalk (in)
N/A	Any Obstructions?	N/A	N/A	Storm Grate/Utility Hazard?

**CARLEEN WAY DR** None **GRIER SPRINGS LN** StopSign Possible Solutions: Remove & Replace Curb Ramp With Two New Directional Ramps or Equivalent. Surveyor Notes:
