# Access Compliance Report

## Public Rights-of-Way

### (Curb Ramps)

Intersection ID: 4889	Main Street: CELOSIA_DR	Cross Street: PAVILION_BV	Location: NE
ADA ID: 63023C7DCDAA	Ramp Type: Perp	Initial Pass/Fail: Fail	Overall Compliance: No
Severity Score: 33.75			
Codes/Mitigation Info/Possible Solution		Field Measurements/Component Compliance

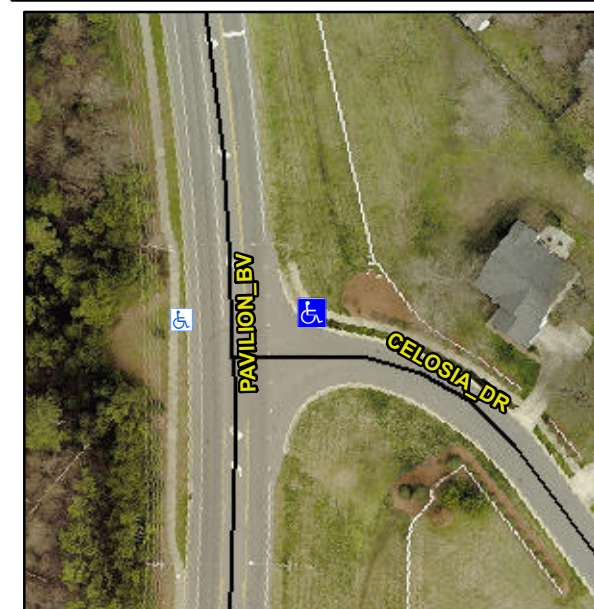
Compliance	Description	Data	Compliance	Description	Data
N/A	Ramp Length (in)	96.0	No	Ramp Slope (%)	13.0
No	Ramp Width (in)	43.0	Yes	Ramp XSlope (%)	1.7
N/A	Flare Type LT	N/A	N/A	Flare Type RT	N/A
N/A	Flare Slope LT (%)	N/A	N/A	Flare Slope RT (%)	N/A
N/A	Flare Traversable LT?	N/A	N/A	Flare Traversable RT?	N/A
N/A	Landing Length (in)	N/A	N/A	DWS Provided?	N/A
N/A	Landing Width (in)	N/A	N/A	DWS Contrast?	N/A
N/A	Landing Slope (%)	N/A	N/A	DWS Length (in)	N/A
N/A	Landing X Slope (%)	N/A	N/A	DWS Full Width?	N/A
N/A	Landing Curb? (Y/N)	N/A	N/A	DWS Offset (in)	N/A
N/A	Shared Landing?	N/A			
N/A	Gutter Ponding?	N/A	N/A	Gutter Slope (%)	N/A
N/A	Gutter Lip Ht (in)	N/A	N/A	Gutter X Slope (%)	N/A
N/A	Painted X Walk1?	No	N/A	Painted X Walk2?	N/A
	X Walk 1 Direction	To W		X Walk 2 Direction	N/A
N/A	X Walk 1 Width (in)	N/A	N/A	X Walk 2 Width (in)	N/A
	X Walk 1 Slope (%)	6.8		X Walk 2 Slope (%)	N/A
	X Walk 1 X Slope (%)	1.3		X Walk 2 X Slope (%)	N/A

N/A	Ramp inside XWalk1?	N/A	N/A	Ramp inside XWalk2?	N/A
	Road Slope (%)	N/A	N/A	Clear Space?	N/A
	Road X Slope (%)	N/A	N/A	Clear Space to XWalk (in)	N/A
N/A	Any Obstructions?	N/A	N/A	Storm Grate/Utility Hazard?	N/A
	Obstruction Type			Storm Grate/Utility Type	
		N/A			N/A
			Yes	Surface Condition? (G/P)	Good

Possible Solutions:

**Remove & Replace Entire Ramp.**

**R304.5.1, R304.2.2**

Total Cost: \$ 1850.00
