# Access Compliance Report

## Public Rights-of-Way

### (Curb Ramps)

| Intersection ID: 2527 | Main Street: CAMBRIDGE_BAY_DR | Cross Street: LAGRANDE_DR | Location: SW |

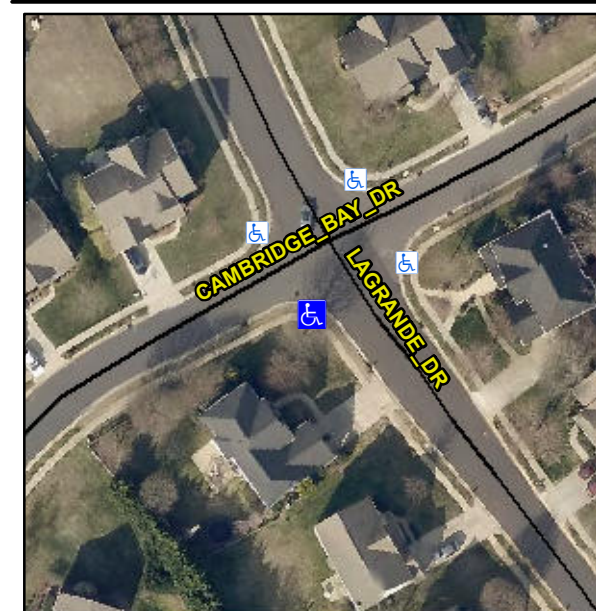
| Compliance | Description | Data | Compliance | Description | Data |
|---|---|---|---|---|---|
| No | Landing Slope (%) | 3.3 | Yes | DWS Length (in) | 24.0 |
| No | Landing X Slope (%) | 3.7 | Yes | DWS Full Width? | Yes |
| N/A | Landing Curb? (Y/N) | No | No | DWS Offset (in) | 4.0 |
| Yes | Gutter Lip Ht (in) | 0.0 | No | Gutter X Slope (%) | 3.1 |

**Remove & Replace Curb Ramp With Two New Directional Ramps or Equivalent. Remove & Replace Gutter.**
