# Access Compliance Report

## Public Rights-of-Way

### (Curb Ramps)

Intersection ID: 19904	Main Street: FALLOW_LN	Cross Street: THORNFIELD_RD	Location: SW
ADA ID: 63061ED1A36A	Ramp Type: BlendTrans2	Initial Pass/Fail: Pass	Overall Compliance: No
Severity Score: 22.5			
Codes/Mitigation Info/Possible Solution		Field Measurements/Component Compliance

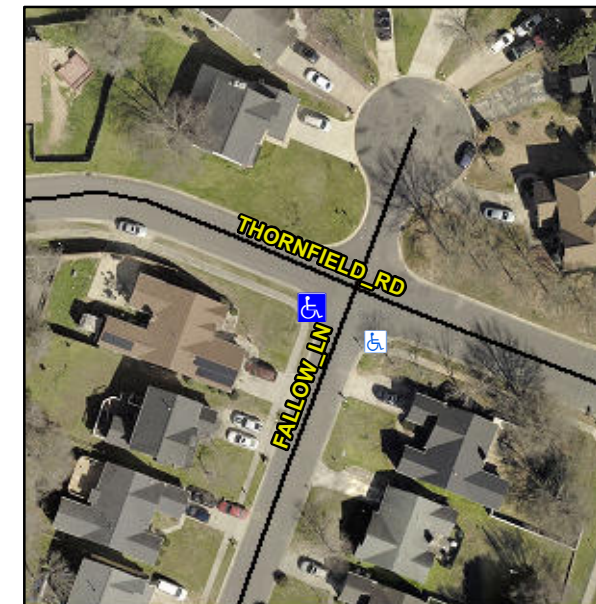
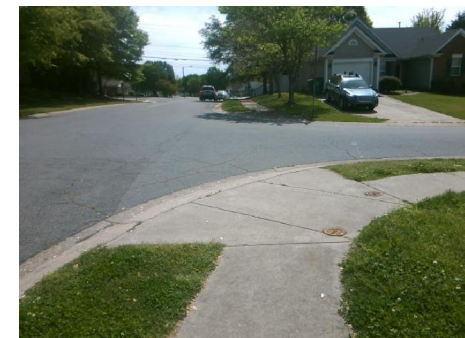
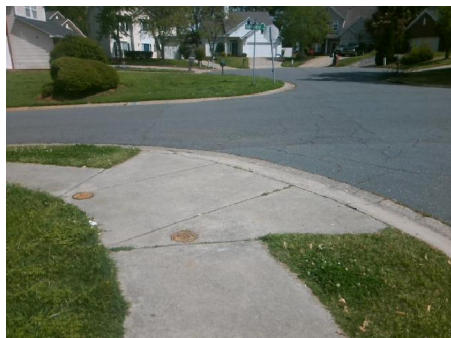
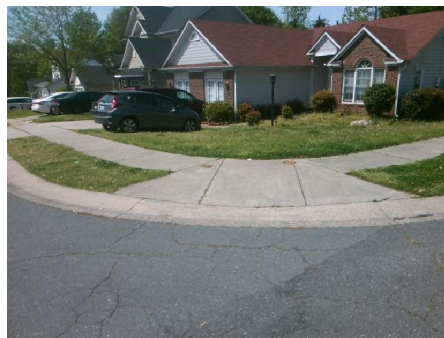
**Not Found, R305, R302.7.2, R304.5.4**

Compliance	Description	Data	Compliance	Description	Data
N/A	Ramp Length (in)	96.0	Yes	BlendTrans Slope (%)	3.4
Yes	Ramp Width (in)	87.0	Yes	BlendTrans XSlope (%)	0.6
N/A	Flare Type LT	Sloped	N/A	Flare Type RT	Sloped
N/A	Flare Slope LT (%)	2.7	N/A	Flare Slope RT (%)	1.1
N/A	Flare Traversable LT?	No	N/A	Flare Traversable RT?	No
N/A	Landing Length (in)	N/A	No	DWS Provided?	No
N/A	Landing Width (in)	N/A	N/A	DWS Contrast?	No
N/A	Landing Slope (%)	N/A	N/A	DWS Length (in)	N/A
N/A	Landing X Slope (%)	N/A	N/A	DWS Full Width?	No
N/A	Landing Curb? (Y/N)	No	N/A	DWS Offset (in)	N/A
N/A	Shared Landing?	No			
Yes	Gutter Ponding?	No	No	Gutter Slope (%)	11.7
No	Gutter Lip Ht (in)	0.5	Yes	Gutter X Slope (%)	0.4
N/A	Painted X Walk1?	No	N/A	Painted X Walk2?	No
	X Walk 1 Direction	To SE		X Walk 2 Direction	To N
	X Walk 1 Width (in)	N/A		X Walk 2 Width (in)	N/A
	X Walk 1 Slope (%)	3.5		X Walk 2 Slope (%)	3.7
	X Walk 1 X Slope (%)	4.0		X Walk 2 X Slope (%)	3.8

N/A	Ramp inside XWalk1?	N/A	N/A	Ramp inside XWalk2?	N/A
	Road Slope (%)	0.2		Clear Space?	Yes
	Road X Slope (%)	7.3	N/A	Clear Space to XWalk (in)	N/A
Yes	Any Obstructions?	No	Yes	Storm Grate/Utility Hazard?	No
	Obstruction Type			Storm Grate/Utility Type	
		N/A			N/A
			Yes	Surface Condition? (G/P)	Good
			No	Curb Slope (%)	5.3

Possible Solutions:

**Remove & Replace Curb Ramp With Two New Directional Ramps or Equivalent. Remove & Replace Gutter.**
