Access Compliance Report

Public Rights-of-Way

(Curb Ramps)

Intersection ID: 32143	Main Street: NEVERMORE_WY	Cross Street: POE_CT	Location: SW
ADA ID: 6309D01395CA	Ramp Type: PerpDiag	Initial Pass/Fail: Fail	Overall Compliance: No
Severity Score: 10			
Codes/Mitigation Info/Possible Solution		Field Measurements/Component Compliance

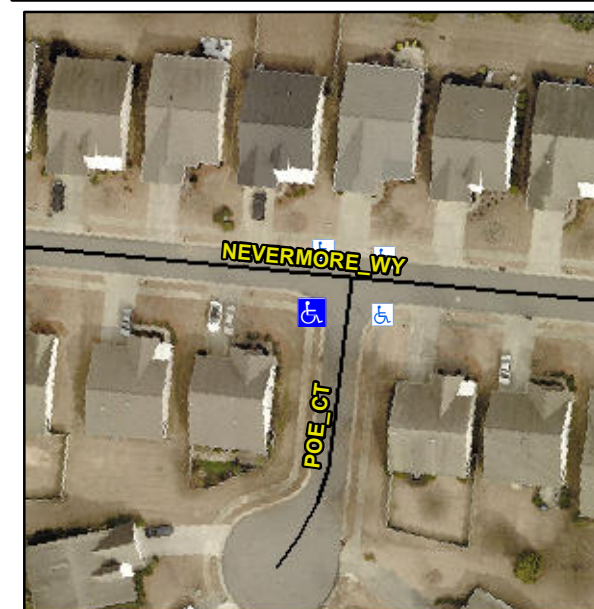
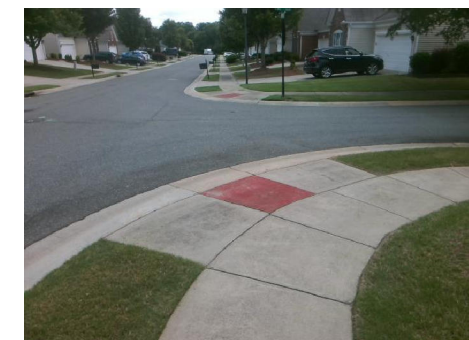
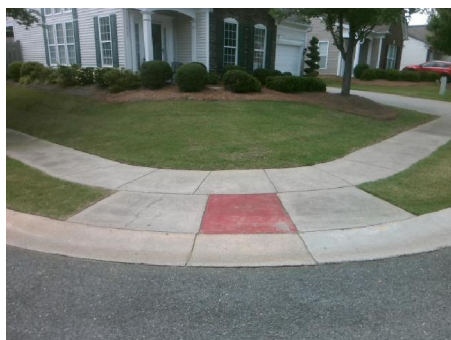
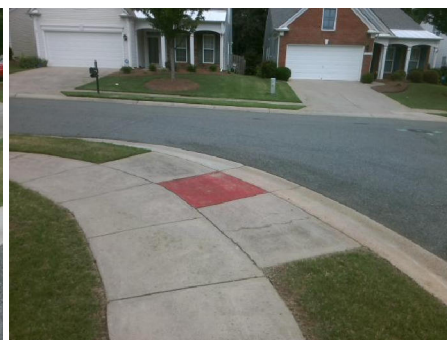
Not Found, R304.5.1, R304.5.3

Compliance	Description	Data	Compliance	Description	Data
N/A	Ramp Length (in)	47.0	Yes	Ramp Slope (%)	5.8
No	Ramp Width (in)	38.0	No	Ramp XSlope (%)	4.0
N/A	Flare Type LT	N/A	N/A	Flare Type RT	N/A
N/A	Flare Slope LT (%)	N/A	N/A	Flare Slope RT (%)	N/A
N/A	Flare Traversable LT?	N/A	N/A	Flare Traversable RT?	N/A
N/A	Landing Length (in)	N/A	N/A	DWS Provided?	N/A
N/A	Landing Width (in)	N/A	N/A	DWS Contrast?	N/A
N/A	Landing Slope (%)	N/A	N/A	DWS Length (in)	N/A
N/A	Landing X Slope (%)	N/A	N/A	DWS Full Width?	N/A
N/A	Landing Curb? (Y/N)	N/A	N/A	DWS Offset (in)	N/A
N/A	Shared Landing?	N/A			
N/A	Gutter Ponding?	N/A	N/A	Gutter Slope (%)	N/A
N/A	Gutter Lip Ht (in)	N/A	N/A	Gutter X Slope (%)	N/A
N/A	Painted X Walk1?	No	N/A	Painted X Walk2?	No
	X Walk 1 Direction	To SE		X Walk 2 Direction	To NE
N/A	X Walk 1 Width (in)	N/A	N/A	X Walk 2 Width (in)	N/A
	X Walk 1 Slope (%)	2.0		X Walk 2 Slope (%)	4.1
	X Walk 1 X Slope (%)	1.3		X Walk 2 X Slope (%)	2.4

N/A	Ramp inside XWalk1?	N/A	N/A	Ramp inside XWalk2?	N/A
	Road Slope (%)	4.2	N/A	Clear Space?	N/A
	Road X Slope (%)	0.3	N/A	Clear Space to XWalk (in)	N/A
N/A	Any Obstructions?	N/A	N/A	Storm Grate/Utility Hazard?	N/A
	Obstruction Type			Storm Grate/Utility Type	
		N/A			N/A
		Yes		Surface Condition? (G/P)	Good

Remove & Replace Curb Ramp With Two New Directional Ramps or Equivalent.
