Access Compliance Report

Public Rights-of-Way

(Curb Ramps)

Intersection ID: 8835	Main Street: BRADFORD_DR	Cross Street: NORTH_AV	Location: NW
ADA ID: 63101E4235D5	Ramp Type: Perp	Initial Pass/Fail: Fail	Overall Compliance: No
		Severity Score: 12.5

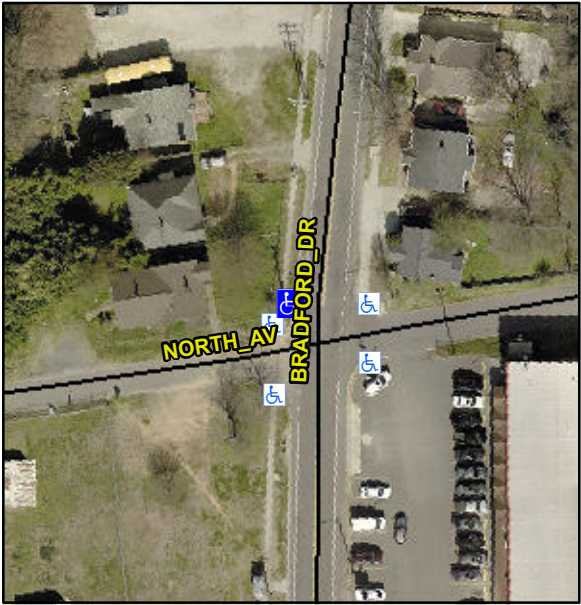
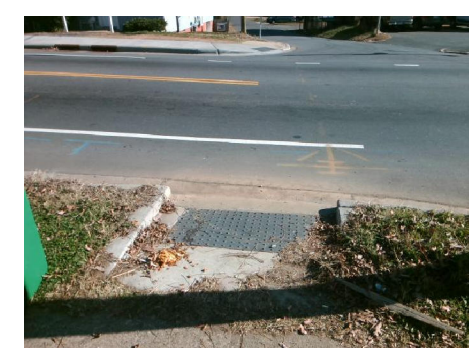
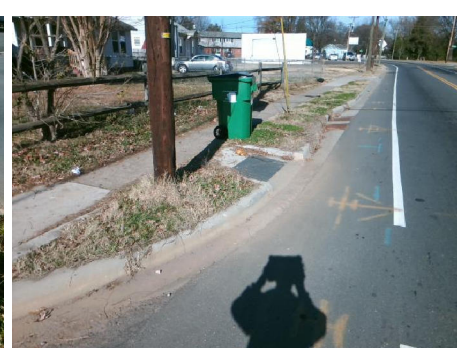
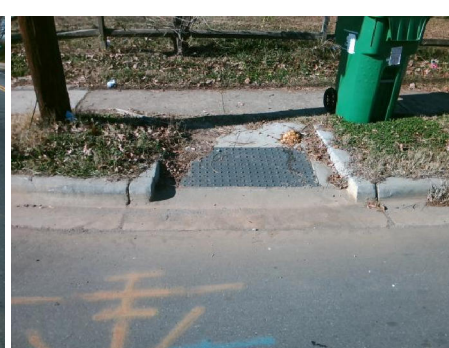
Possible Solutions:		Compliance	Description	Data
	Remove & Replace Entire Ramp.		No	Ramp Length (in)	49.0
			Yes	Ramp Width (in)	48.0
			N/A	Flare Type LT	N/A
			N/A	Flare Slope LT (%)	N/A
			N/A	Flare Traversable LT?	N/A
			N/A	Landing Length (in)	N/A
			N/A	Landing Width (in)	N/A
			N/A	Landing Slope (%)	N/A
			N/A	Landing X Slope (%)	N/A
<p>Surveyor Notes:</p> <p>N/A</p> <p>PROW/ADA:</p> <p>Not Found, R304.2.2</p>			N/A	Flare Type RT	N/A
			N/A	Flare Slope RT (%)	N/A
			N/A	Flare Traversable RT?	N/A
			N/A	DWS Provided?	N/A
			N/A	DWS Contrast?	N/A
			N/A	DWS Length (in)	N/A
			N/A	DWS Full Width?	N/A
			N/A	DWS Offset (in)	N/A
			N/A	Shared Landing?	N/A
			N/A	Gutter Ponding?	N/A
			N/A	Gutter Lip Ht (in)	N/A
			N/A	Painted X Walk1?	No
				X Walk 1 Direction	To E
			N/A	X Walk 1 Width (in)	N/A
				X Walk 1 Slope (%)	3.5
				X Walk 1 X Slope (%)	0.1

N/A	Ramp inside XWalk1?	N/A
			N/A	Road Slope (%)	N/A
			N/A	Road X Slope (%)	N/A
			N/A	Any Obstructions?	N/A
Total Cost:		\$ 1850.00		Obstruction Type	
			N/A		N/A
			Yes	Surface Condition? (G/P)	Good
