Access Compliance Report

Public Rights-of-Way

(Curb Ramps)

Intersection ID: 3226	Main Street: CANBURY_CT	Cross Street: WORSLEY_LN	Location: S
ADA ID: 63104F5F4DA5	Ramp Type: Perp	Initial Pass/Fail: Fail	Overall Compliance: No
Severity Score: 8.75			
Codes/Mitigation Info/Possible Solution		Field Measurements/Component Compliance

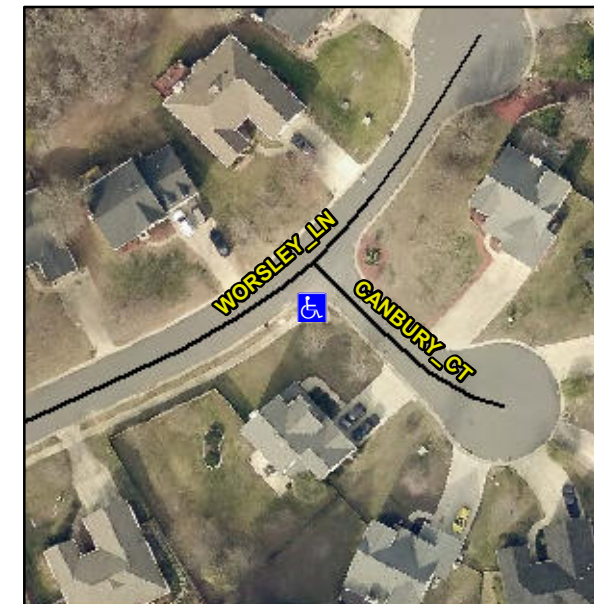
Not Found, R304.5.1

Compliance	Description	Data	Compliance	Description	Data
N/A	Ramp Length (in)	98.0	Yes	Ramp Slope (%)	5.8
No	Ramp Width (in)	47.0	Yes	Ramp XSlope (%)	1.3
N/A	Flare Type LT	N/A	N/A	Flare Type RT	N/A
N/A	Flare Slope LT (%)	N/A	N/A	Flare Slope RT (%)	N/A
N/A	Flare Traversable LT?	N/A	N/A	Flare Traversable RT?	N/A
N/A	Landing Length (in)	N/A	N/A	DWS Provided?	N/A
N/A	Landing Width (in)	N/A	N/A	DWS Contrast?	N/A
N/A	Landing Slope (%)	N/A	N/A	DWS Length (in)	N/A
N/A	Landing X Slope (%)	N/A	N/A	DWS Full Width?	N/A
N/A	Landing Curb? (Y/N)	N/A	N/A	DWS Offset (in)	N/A
N/A	Shared Landing?	N/A			
N/A	Gutter Ponding?	N/A	N/A	Gutter Slope (%)	N/A
N/A	Gutter Lip Ht (in)	N/A	N/A	Gutter X Slope (%)	N/A
N/A	Painted X Walk1?	No	N/A	Painted X Walk2?	N/A
	X Walk 1 Direction	To NE		X Walk 2 Direction	N/A
N/A	X Walk 1 Width (in)	N/A	N/A	X Walk 2 Width (in)	N/A
	X Walk 1 Slope (%)	1.1		X Walk 2 Slope (%)	N/A
	X Walk 1 X Slope (%)	1.0		X Walk 2 X Slope (%)	N/A

N/A	Ramp inside XWalk1?	N/A	N/A	Ramp inside XWalk2?	N/A
	Road Slope (%)	N/A	N/A	Clear Space?	N/A
	Road X Slope (%)	N/A	N/A	Clear Space to XWalk (in)	N/A
N/A	Any Obstructions?	N/A	N/A	Storm Grate/Utility Hazard?	N/A
	Obstruction Type			Storm Grate/Utility Type	
		N/A			N/A
			Yes	Surface Condition? (G/P)	Good

Possible Solutions:

Remove & Replace Entire Ramp.
