Access Compliance Report

Public Rights-of-Way

(Curb Ramps)

Intersection ID: 52226	Main Street: AMESBURY_HILL_DR	Cross Street: AUBURN_HILL_LN	Location: SW
ADA ID: 631577E3A794	Ramp Type: Perp	Initial Pass/Fail: Fail	Overall Compliance: No
Severity Score: 10			
Codes/Mitigation Info/Possible Solution		Field Measurements/Component Compliance

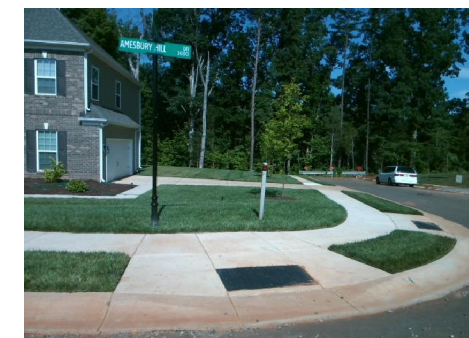
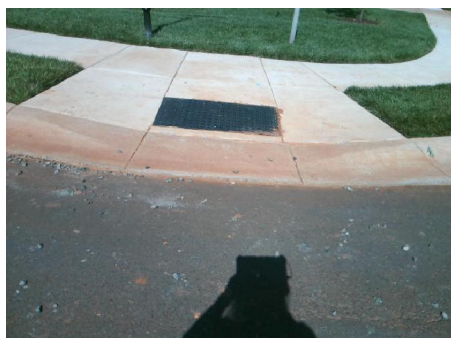
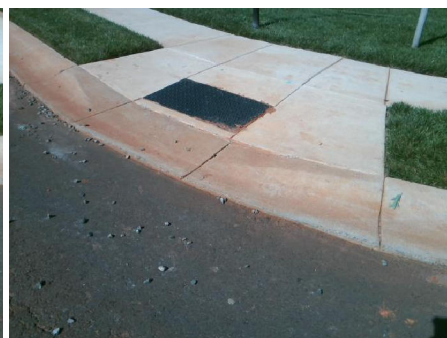
Compliance	Description	Data	Compliance	Description	Data
N/A	Ramp Length (in)	50.0	Yes	Ramp Slope (%)	6.5
No	Ramp Width (in)	45.5	No	Ramp XSlope (%)	3.1
N/A	Flare Type LT	N/A	N/A	Flare Type RT	N/A
N/A	Flare Slope LT (%)	N/A	N/A	Flare Slope RT (%)	N/A
N/A	Flare Traversable LT?	N/A	N/A	Flare Traversable RT?	N/A
N/A	Landing Length (in)	N/A	N/A	DWS Provided?	N/A
N/A	Landing Width (in)	N/A	N/A	DWS Contrast?	N/A
N/A	Landing Slope (%)	N/A	N/A	DWS Length (in)	N/A
N/A	Landing X Slope (%)	N/A	N/A	DWS Full Width?	N/A
N/A	Landing Curb? (Y/N)	N/A	N/A	DWS Offset (in)	N/A
N/A	Shared Landing?	N/A			
N/A	Gutter Ponding?	N/A	N/A	Gutter Slope (%)	N/A
N/A	Gutter Lip Ht (in)	N/A	N/A	Gutter X Slope (%)	N/A
N/A	Painted X Walk1?	No	N/A	Painted X Walk2?	N/A
	X Walk 1 Direction	To E		X Walk 2 Direction	N/A
N/A	X Walk 1 Width (in)	N/A	N/A	X Walk 2 Width (in)	N/A
	X Walk 1 Slope (%)	10.5		X Walk 2 Slope (%)	N/A
	X Walk 1 X Slope (%)	1.7		X Walk 2 X Slope (%)	N/A

N/A	Ramp inside XWalk1?	N/A	N/A	Ramp inside XWalk2?	N/A
	Road Slope (%)	N/A	N/A	Clear Space?	N/A
	Road X Slope (%)	N/A	N/A	Clear Space to XWalk (in)	N/A
N/A	Any Obstructions?	N/A	N/A	Storm Grate/Utility Hazard?	N/A
	Obstruction Type			Storm Grate/Utility Type	
		N/A			N/A
			Yes	Surface Condition? (G/P)	Good

Possible Solutions:

Remove & Replace Entire Ramp.

R304.5.1, R304.5.3
