Access Compliance Report

Public Rights-of-Way

(Curb Ramps)

Intersection ID: 25298	Main Street: PROVIDENCE_RD	Cross Street: WINDBLUFF_DR	Location: SW
ADA ID: 632A2D082D89	Ramp Type: BlendTrans2	Initial Pass/Fail: Fail	Overall Compliance: No
Severity Score: 10			
Codes/Mitigation Info/Possible Solution		Field Measurements/Component Compliance

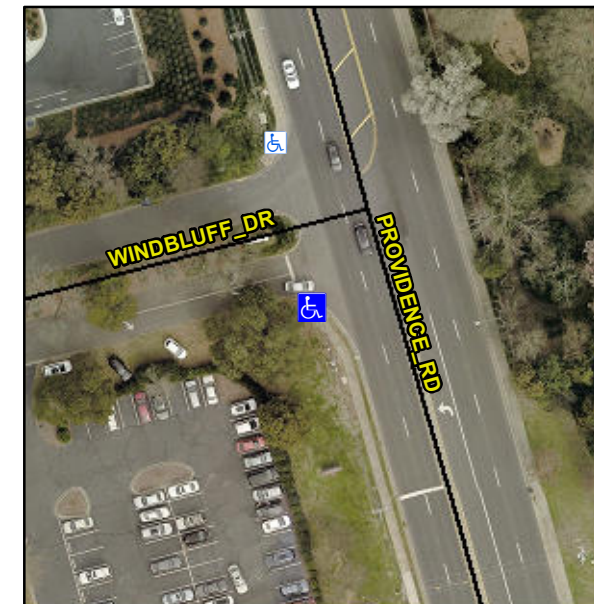
Compliance	Description	Data	Compliance	Description	Data
N/A	Ramp Length (in)	89.0	Yes	BlendTrans Slope (%)	3.8
No	Ramp Width (in)	42.0	No	BlendTrans XSlope (%)	4.3
N/A	Flare Type LT	N/A	N/A	Flare Type RT	N/A
N/A	Flare Slope LT (%)	N/A	N/A	Flare Slope RT (%)	N/A
N/A	Flare Traversable LT?	N/A	N/A	Flare Traversable RT?	N/A
N/A	Landing Length (in)	N/A	N/A	DWS Provided?	N/A
N/A	Landing Width (in)	N/A	N/A	DWS Contrast?	N/A
N/A	Landing Slope (%)	N/A	N/A	DWS Length (in)	N/A
N/A	Landing X Slope (%)	N/A	N/A	DWS Full Width?	N/A
N/A	Landing Curb? (Y/N)	N/A	N/A	DWS Offset (in)	N/A
N/A	Shared Landing?	N/A			
N/A	Gutter Ponding?	N/A	N/A	Gutter Slope (%)	N/A
N/A	Gutter Lip Ht (in)	N/A	N/A	Gutter X Slope (%)	N/A
N/A	Painted X Walk1?	No	N/A	Painted X Walk2?	No
	X Walk 1 Direction	To E		X Walk 2 Direction	To N
	X Walk 1 Width (in)	N/A		X Walk 2 Width (in)	N/A
	X Walk 1 Slope (%)	3.1		X Walk 2 Slope (%)	0.6
	X Walk 1 X Slope (%)	1.0		X Walk 2 X Slope (%)	5.2

N/A	Ramp inside XWalk1?	N/A	N/A	Ramp inside XWalk2?	N/A
	Road Slope (%)	6.0		Clear Space?	N/A
	Road X Slope (%)	1.0	N/A	Clear Space to XWalk (in)	N/A
N/A	Any Obstructions?	N/A	N/A	Storm Grate/Utility Hazard?	N/A
	Obstruction Type			Storm Grate/Utility Type	
		N/A			N/A
			Yes	Surface Condition? (G/P)	Good
			N/A	Curb Slope (%)	4.4

Possible Solutions:

Remove & Replace Curb Ramp With Two New Directional Ramps or Equivalent.

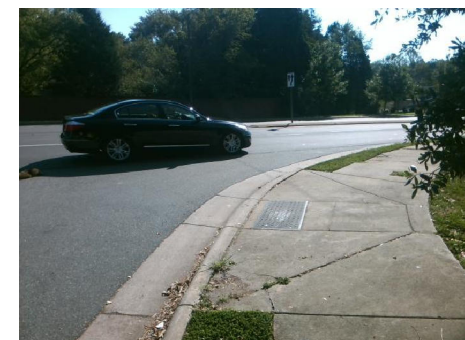
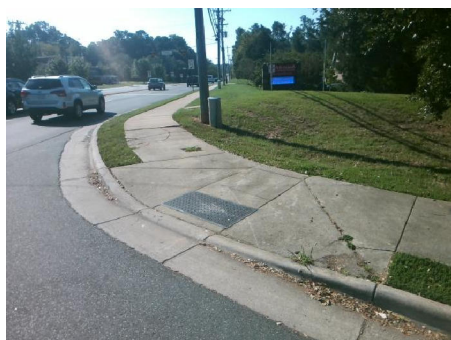
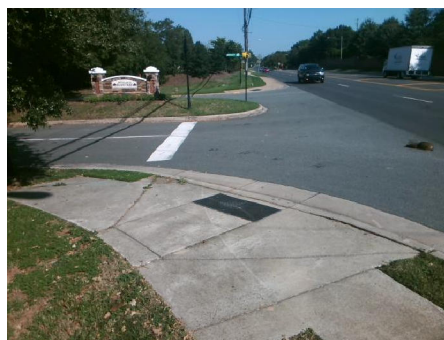
Street 1 Name PROVIDENCE RD

Stop Condition-Street 1 None

Street 2 Name WINDBLUFF DR

Stop Condition-Street 2 StopSign
