Access Compliance Report

Public Rights-of-Way

(Curb Ramps)

Intersection ID: 13590	Main Street: CAMDEN_RD	Cross Street: TRYON_ST	Location: SE
ADA ID: 633C48E968C4	Ramp Type: Perp	Initial Pass/Fail: Fail	Overall Compliance: No
		Severity Score: 25

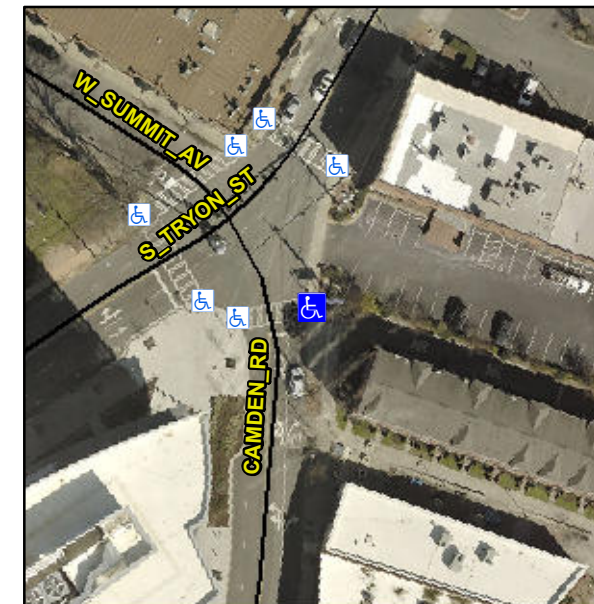
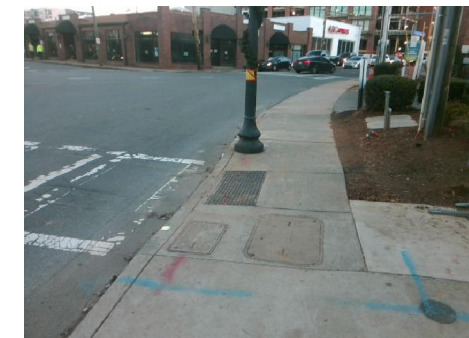
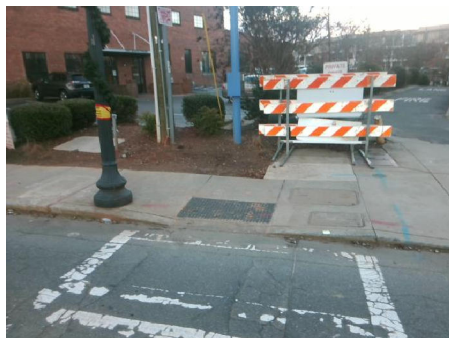
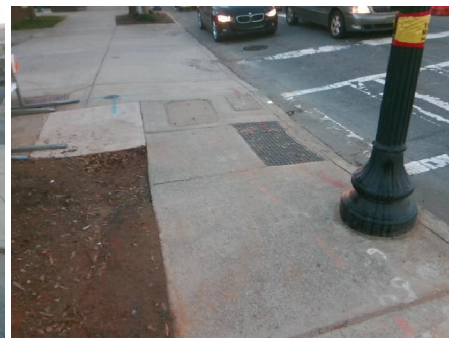
Not Found, R304.2.2, R304.5.3

Compliance	Description	Data	Compliance	Description	Data
N/A	Ramp Length (in)	27.0	No	Ramp Slope (%)	10.6
Yes	Ramp Width (in)	48.0	No	Ramp XSlope (%)	5.4
N/A	Flare Type LT	N/A	N/A	Flare Type RT	N/A
N/A	Flare Slope LT (%)	N/A	N/A	Flare Slope RT (%)	N/A
N/A	Flare Traversable LT?	N/A	N/A	Flare Traversable RT?	N/A
N/A	Landing Length (in)	N/A	N/A	DWS Provided?	N/A
N/A	Landing Width (in)	N/A	N/A	DWS Contrast?	N/A
N/A	Landing Slope (%)	N/A	N/A	DWS Length (in)	N/A
N/A	Landing X Slope (%)	N/A	N/A	DWS Full Width?	N/A
N/A	Landing Curb? (Y/N)	N/A	N/A	DWS Offset (in)	N/A
N/A	Shared Landing?	N/A			
N/A	Gutter Ponding?	N/A	N/A	Gutter Slope (%)	N/A
N/A	Gutter Lip Ht (in)	N/A	N/A	Gutter X Slope (%)	N/A
N/A	Painted X Walk1?	Yes	N/A	Painted X Walk2?	N/A
	X Walk 1 Direction	To W		X Walk 2 Direction	N/A
N/A	X Walk 1 Width (in)	99.0	N/A	X Walk 2 Width (in)	N/A
	X Walk 1 Slope (%)	4.2		X Walk 2 Slope (%)	N/A
	X Walk 1 X Slope (%)	1.6		X Walk 2 X Slope (%)	N/A

N/A	Ramp inside XWalk1?	Yes	N/A	Ramp inside XWalk2?	N/A
	Road Slope (%)	N/A	N/A	Clear Space?	N/A
	Road X Slope (%)	N/A	N/A	Clear Space to XWalk (in)	N/A
N/A	Any Obstructions?	N/A	N/A	Storm Grate/Utility Hazard?	N/A
	Obstruction Type			Storm Grate/Utility Type	
		N/A			N/A
			Yes	Surface Condition? (G/P)	Good

Remove & Replace Entire Ramp.
