Access Compliance Report

Public Rights-of-Way

(Curb Ramps)

Intersection ID: 27200	Main Street: ANNALEXA_LN	Cross Street: BALLANTYNE_COMMONS_PY	Location: SE
ADA ID: 6345F23E557A	Ramp Type: Perp	Initial Pass/Fail: Fail	Overall Compliance: No
		Severity Score: 8.75

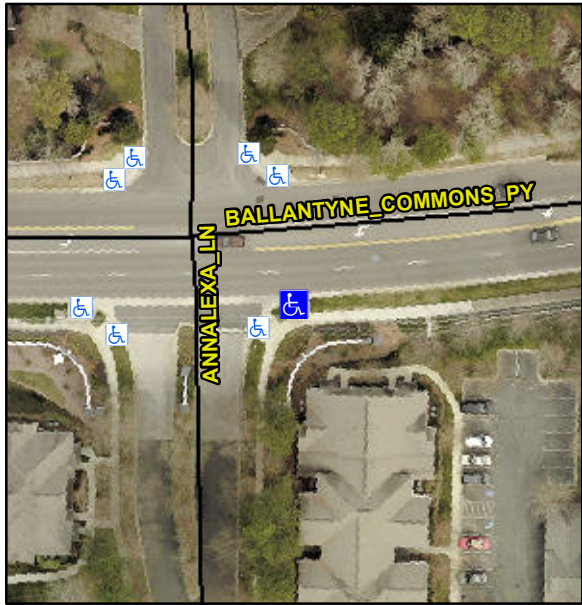
Possible Solutions:		Compliance	Description	Data	Compliance	Description	Data
	Remove & Replace Entire Ramp.		N/A	Ramp Length (in)	95.0	Yes	Ramp Slope (%)	6.7
			No	Ramp Width (in)	41.5	Yes	Ramp XSlope (%)	1.6
			N/A	Flare Type LT	N/A	N/A	Flare Type RT	N/A
			N/A	Flare Slope LT (%)	N/A	N/A	Flare Slope RT (%)	N/A
			N/A	Flare Traversable LT?	N/A	N/A	Flare Traversable RT?	N/A
			N/A	Landing Length (in)	N/A	N/A	DWS Provided?	N/A
			N/A	Landing Width (in)	N/A	N/A	DWS Contrast?	N/A
			N/A	Landing Slope (%)	N/A	N/A	DWS Length (in)	N/A
			N/A	Landing X Slope (%)	N/A	N/A	DWS Full Width?	N/A
Surveyor Notes:	N/A		N/A	Landing Curb? (Y/N)	N/A	N/A	DWS Offset (in)	N/A
			N/A	Shared Landing?	N/A			
	PROW/ADA:		N/A	Gutter Ponding?	N/A	N/A	Gutter Slope (%)	N/A
	Not Found, R304.5.1		N/A	Gutter Lip Ht (in)	N/A	N/A	Gutter X Slope (%)	N/A

N/A	Painted X Walk1?	No	N/A	Painted X Walk2?	N/A
				X Walk 1 Direction	To N		X Walk 2 Direction	N/A
			N/A	X Walk 1 Width (in)	N/A	N/A	X Walk 2 Width (in)	N/A
				X Walk 1 Slope (%)	3.7		X Walk 2 Slope (%)	N/A
				X Walk 1 X Slope (%)	1.1		X Walk 2 X Slope (%)	N/A
			N/A	Ramp inside XWalk1?	N/A	N/A	Ramp inside XWalk2?	N/A
			Road Slope (%)	N/A	N/A	Clear Space?	N/A	
			Road X Slope (%)	N/A	N/A	Clear Space to XWalk (in)	N/A	
		N/A	Any Obstructions?	N/A	N/A	Storm Grate/Utility Hazard?	N/A	
			Obstruction Type			Storm Grate/Utility Type		
					N/A		N/A	
					Yes	Surface Condition? (G/P)	Good	
Total Cost:		\$	1850.00
