Access Compliance Report

Public Rights-of-Way (Curb Ramps)

Intersection ID: 10013834	Main Street: IKEA_BV	Cross Street: N/A	Location: SW
ADA ID: 6367C64DABAB	Ramp Type: PerpDiag	Initial Pass/Fail: Fail	Overall Compliance: No
Severity Score: 8.75			
Codes/Mitigation Info/Possible Solution		Field Measurements/Component Compliance

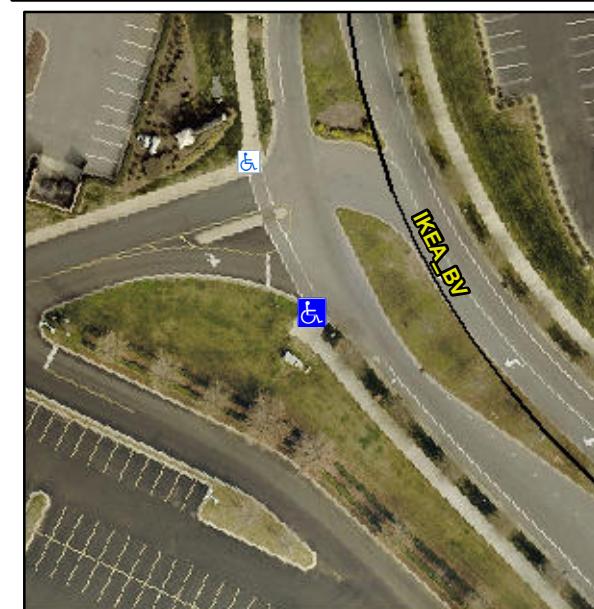
Not Found, R304.5.1

Compliance	Description	Data	Compliance	Description	Data
N/A	Ramp Length (in)	96.0	Yes	Ramp Slope (%)	7.7
No	Ramp Width (in)	43.5	Yes	Ramp XSlope (%)	1.1
N/A	Flare Type LT	N/A	N/A	Flare Type RT	N/A
N/A	Flare Slope LT (%)	N/A	N/A	Flare Slope RT (%)	N/A
N/A	Flare Traversable LT?	N/A	N/A	Flare Traversable RT?	N/A
N/A	Landing Length (in)	N/A	N/A	DWS Provided?	N/A
N/A	Landing Width (in)	N/A	N/A	DWS Contrast?	N/A
N/A	Landing Slope (%)	N/A	N/A	DWS Length (in)	N/A
N/A	Landing X Slope (%)	N/A	N/A	DWS Full Width?	N/A
N/A	Landing Curb? (Y/N)	N/A	N/A	DWS Offset (in)	N/A
N/A	Shared Landing?	N/A			
N/A	Gutter Ponding?	N/A	N/A	Gutter Slope (%)	N/A
N/A	Gutter Lip Ht (in)	N/A	N/A	Gutter X Slope (%)	N/A
N/A	Painted X Walk1?	No	N/A	Painted X Walk2?	Yes
	X Walk 1 Direction	To E		X Walk 2 Direction	To N
N/A	X Walk 1 Width (in)	N/A	N/A	X Walk 2 Width (in)	76.0
	X Walk 1 Slope (%)	1.3		X Walk 2 Slope (%)	4.5
	X Walk 1 X Slope (%)	0.9		X Walk 2 X Slope (%)	1.2

N/A	Ramp inside XWalk1?	N/A	N/A	Ramp inside XWalk2?	Yes
	Road Slope (%)	1.4	N/A	Clear Space?	N/A
	Road X Slope (%)	0.4	N/A	Clear Space to XWalk (in)	N/A
N/A	Any Obstructions?	N/A	N/A	Storm Grate/Utility Hazard?	N/A
	Obstruction Type			Storm Grate/Utility Type	
		N/A			N/A
			Yes	Surface Condition? (G/P)	Good

Remove & Replace Curb Ramp With Two New Directional Ramps or Equivalent.

Total Cost: \$ 3200.00
