Access Compliance Report

Public Rights-of-Way

(Curb Ramps)

Intersection ID: 10038802	Main Street: STEELE_CREEK_RD	Cross Street: N/A	Location: SE
ADA ID: 637D27B0B1ED	Ramp Type: BlendTrans2	Initial Pass/Fail: Fail	Overall Compliance: No
Codes/Mitigation Info/Possible Solution		Field Measurements/Component Compliance	
Severity Score: 10

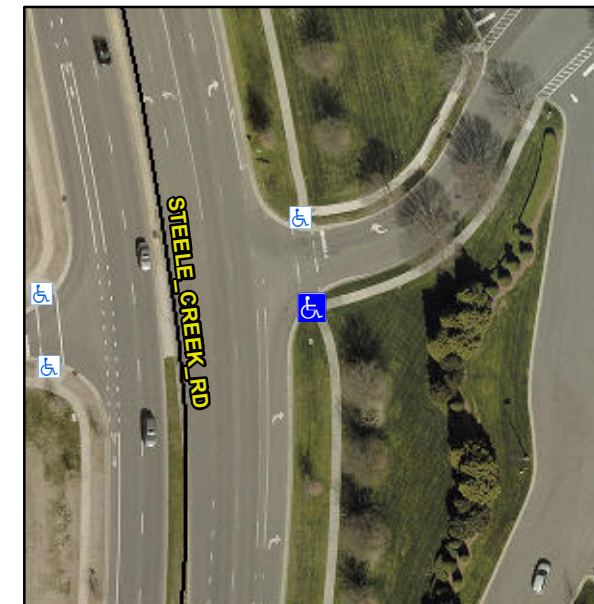
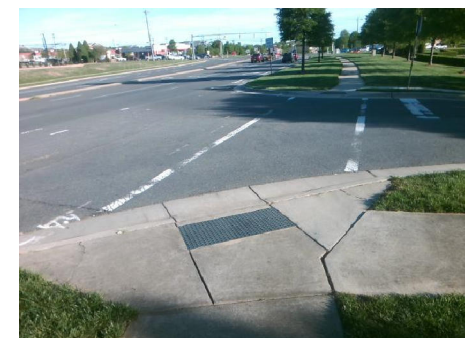
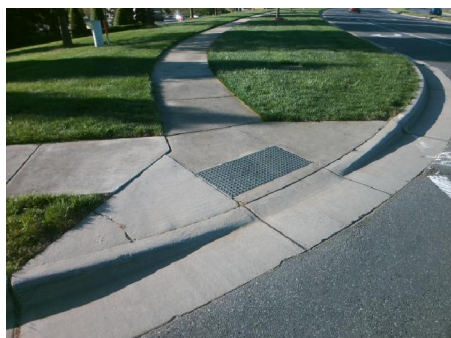
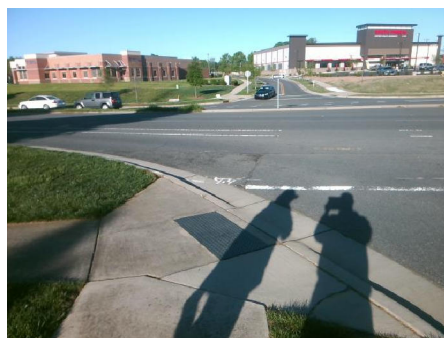
Not Found, R304.5.1, R304.5.3

Compliance	Description	Data	Compliance	Description	Data
N/A	Ramp Length (in)	69.0	Yes	BlendTrans Slope (%)	3.9
No	Ramp Width (in)	38.0	No	BlendTrans XSlope (%)	3.5
N/A	Flare Type LT	N/A	N/A	Flare Type RT	N/A
N/A	Flare Slope LT (%)	N/A	N/A	Flare Slope RT (%)	N/A
N/A	Flare Traversable LT?	N/A	N/A	Flare Traversable RT?	N/A
N/A	Landing Length (in)	N/A	N/A	DWS Provided?	N/A
N/A	Landing Width (in)	N/A	N/A	DWS Contrast?	N/A
N/A	Landing Slope (%)	N/A	N/A	DWS Length (in)	N/A
N/A	Landing X Slope (%)	N/A	N/A	DWS Full Width?	N/A
N/A	Landing Curb? (Y/N)	N/A	N/A	DWS Offset (in)	N/A
N/A	Shared Landing?	N/A			
N/A	Gutter Ponding?	N/A	N/A	Gutter Slope (%)	N/A
N/A	Gutter Lip Ht (in)	N/A	N/A	Gutter X Slope (%)	N/A
N/A	Painted X Walk1?	Yes	N/A	Painted X Walk2?	No
	X Walk 1 Direction	To N		X Walk 2 Direction	To SW
	X Walk 1 Width (in)	113.0		X Walk 2 Width (in)	N/A
	X Walk 1 Slope (%)	1.6		X Walk 2 Slope (%)	0.6
	X Walk 1 X Slope (%)	0.7		X Walk 2 X Slope (%)	0.7

N/A	Ramp inside XWalk1?	Yes	N/A	Ramp inside XWalk2?	N/A
	Road Slope (%)	0.6		Clear Space?	N/A
	Road X Slope (%)	0.3	N/A	Clear Space to XWalk (in)	N/A
N/A	Any Obstructions?	N/A	N/A	Storm Grate/Utility Hazard?	N/A
	Obstruction Type			Storm Grate/Utility Type	
		N/A			N/A
			Yes	Surface Condition? (G/P)	Good
			No	Curb Slope (%)	12.3

Possible Solutions:

Remove & Replace Curb Ramp With Two New Directional Ramps or Equivalent.
