Access Compliance Report

Public Rights-of-Way

(Curb Ramps)

Intersection ID: 26014	Main Street: ARRINGTON MANOR PL	Cross Street: HOLLY HILL FARM RD	Location: NW
ADA ID: 6380A40CA281	Ramp Type: BlendTrans2	Initial Pass/Fail: Fail	Overall Compliance: No
Severity Score: 25			
Codes/Mitigation Info/Possible Solution		Field Measurements/Component Compliance

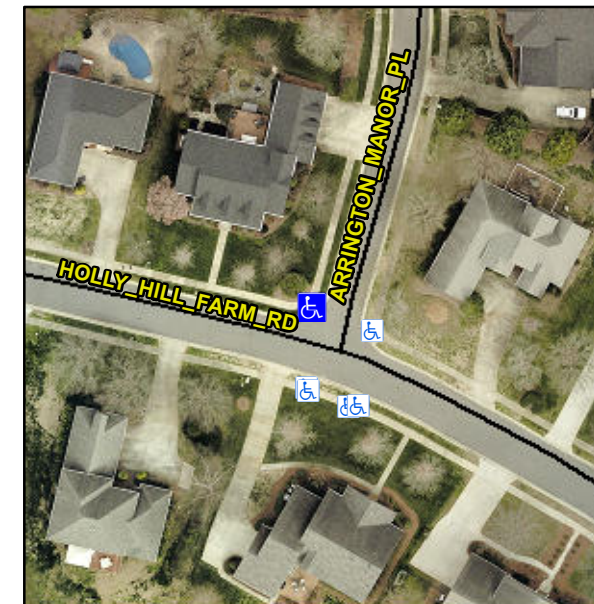
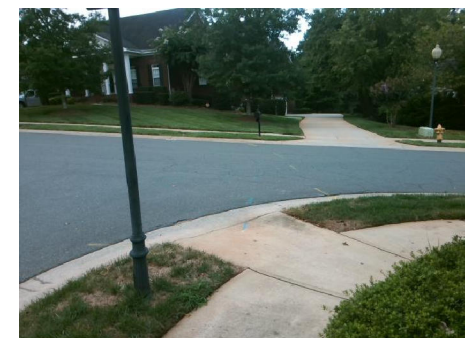
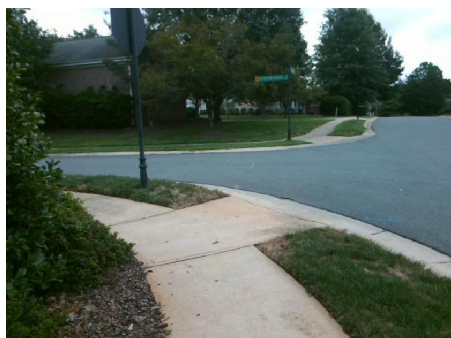
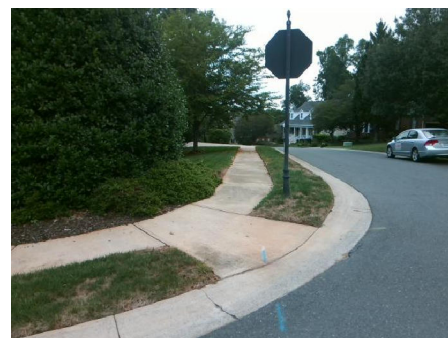
Compliance	Description	Data	Compliance	Description	Data
N/A	Ramp Length (in)	97.0	Yes	BlendTrans Slope (%)	2.5
Yes	Ramp Width (in)	76.0	No	BlendTrans XSlope (%)	11.2
N/A	Flare Type LT	N/A	N/A	Flare Type RT	N/A
N/A	Flare Slope LT (%)	N/A	N/A	Flare Slope RT (%)	N/A
N/A	Flare Traversable LT?	N/A	N/A	Flare Traversable RT?	N/A
N/A	Landing Length (in)	N/A	N/A	DWS Provided?	N/A
N/A	Landing Width (in)	N/A	N/A	DWS Contrast?	N/A
N/A	Landing Slope (%)	N/A	N/A	DWS Length (in)	N/A
N/A	Landing X Slope (%)	N/A	N/A	DWS Full Width?	N/A
N/A	Landing Curb? (Y/N)	N/A	N/A	DWS Offset (in)	N/A
N/A	Shared Landing?	N/A			
N/A	Gutter Ponding?	N/A	N/A	Gutter Slope (%)	N/A
N/A	Gutter Lip Ht (in)	N/A	N/A	Gutter X Slope (%)	N/A
N/A	Painted X Walk1?	No	N/A	Painted X Walk2?	No
	X Walk 1 Direction	To S		X Walk 2 Direction	To SE
	X Walk 1 Width (in)	N/A		X Walk 2 Width (in)	N/A
	X Walk 1 Slope (%)	2.1		X Walk 2 Slope (%)	6.9
	X Walk 1 X Slope (%)	7.1		X Walk 2 X Slope (%)	2.1

N/A	Ramp inside XWalk1?	N/A	N/A	Ramp inside XWalk2?	N/A
	Road Slope (%)	3.3		Clear Space?	N/A
	Road X Slope (%)	6.2	N/A	Clear Space to XWalk (in)	N/A
N/A	Any Obstructions?	N/A	N/A	Storm Grate/Utility Hazard?	N/A
	Obstruction Type			Storm Grate/Utility Type	
		N/A			N/A
			Yes	Surface Condition? (G/P)	Good
			N/A	Curb Slope (%)	4.4

Remove & Replace Curb Ramp With Two New Directional Ramps or Equivalent.

R304.5.3

\$ 3200.00
