Access Compliance Report

Public Rights-of-Way

(Curb Ramps)

Intersection ID: 1003389	Main Street: DAVIS_CROSSING_CT	Cross Street: N/A	Location: W
ADA ID: 638301695973	Ramp Type: Perp	Initial Pass/Fail: Fail	Overall Compliance: No
Severity Score: 8.75			
Codes/Mitigation Info/Possible Solution		Field Measurements/Component Compliance

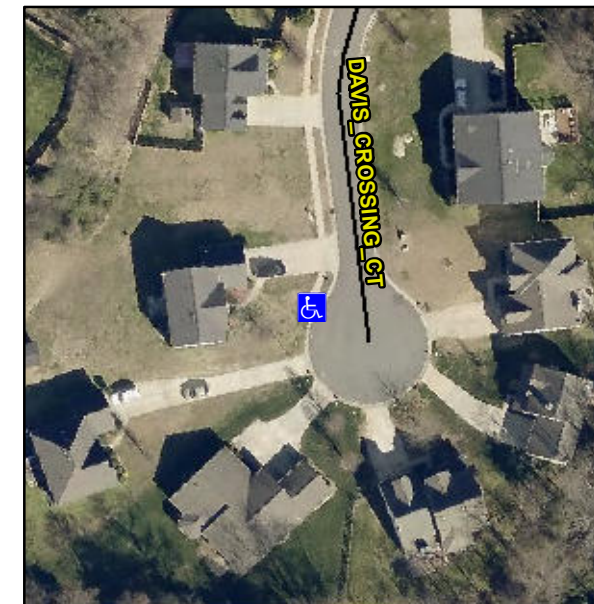
Compliance	Description	Data	Compliance	Description	Data
N/A	Ramp Length (in)	36.0	Yes	Ramp Slope (%)	6.2
No	Ramp Width (in)	47.5	Yes	Ramp XSlope (%)	1.2
N/A	Flare Type LT	N/A	N/A	Flare Type RT	N/A
N/A	Flare Slope LT (%)	N/A	N/A	Flare Slope RT (%)	N/A
N/A	Flare Traversable LT?	N/A	N/A	Flare Traversable RT?	N/A
N/A	Landing Length (in)	N/A	N/A	DWS Provided?	N/A
N/A	Landing Width (in)	N/A	N/A	DWS Contrast?	N/A
N/A	Landing Slope (%)	N/A	N/A	DWS Length (in)	N/A
N/A	Landing X Slope (%)	N/A	N/A	DWS Full Width?	N/A
N/A	Landing Curb? (Y/N)	N/A	N/A	DWS Offset (in)	N/A
N/A	Shared Landing?	N/A			
N/A	Gutter Ponding?	N/A	N/A	Gutter Slope (%)	N/A
N/A	Gutter Lip Ht (in)	N/A	N/A	Gutter X Slope (%)	N/A
N/A	Painted X Walk1?	No	N/A	Painted X Walk2?	N/A
	X Walk 1 Direction	To SE		X Walk 2 Direction	N/A
N/A	X Walk 1 Width (in)	N/A	N/A	X Walk 2 Width (in)	N/A
	X Walk 1 Slope (%)	0.4		X Walk 2 Slope (%)	N/A
	X Walk 1 X Slope (%)	2.9		X Walk 2 X Slope (%)	N/A

N/A	Ramp inside XWalk1?	N/A	N/A	Ramp inside XWalk2?	N/A
	Road Slope (%)	N/A	N/A	Clear Space?	N/A
	Road X Slope (%)	N/A	N/A	Clear Space to XWalk (in)	N/A
N/A	Any Obstructions?	N/A	N/A	Storm Grate/Utility Hazard?	N/A
	Obstruction Type			Storm Grate/Utility Type	
		N/A			N/A
			Yes	Surface Condition? (G/P)	Good

Possible Solutions:

Remove & Replace Entire Ramp.

R304.5.1
