Access Compliance Report Public Rights-of-Way (Curb Ramps)

Intersection ID: N/A Main Street: MCCLINTOCK RD **Cross Street: N/A** Location: SE Initial Pass/Fail: Fail **Overall Compliance: No** 22.5 ADA ID: 6386D84DF526 Ramp Type: Combination1 **Severity Score:**

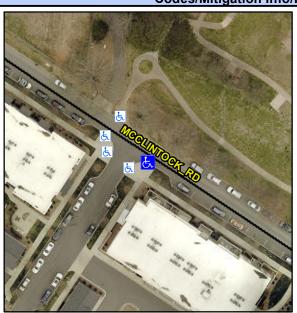
Possible Solutions: Compliance Description Remove & Replace Entire Ramp. N/A Yes Yes No N/A No Surveyor Notes: N/A N/A N/A N/A N/A N/A PROW/ADA: N/A R304.5.1, R304.2.2, R304.5.3, N/A R304.3.2 N/A N/A N/A N/A N/A
