Access Compliance Report

Public Rights-of-Way

(Curb Ramps)

Intersection ID: 30613	Main Street: GOLF_LINKS_DR	Cross Street: PROVIDENCE_RD	Location: SE
ADA ID: 638B2036B46B	Ramp Type: Perp	Initial Pass/Fail: Fail	Overall Compliance: No
Severity Score: 10			
Codes/Mitigation Info/Possible Solution		Field Measurements/Component Compliance

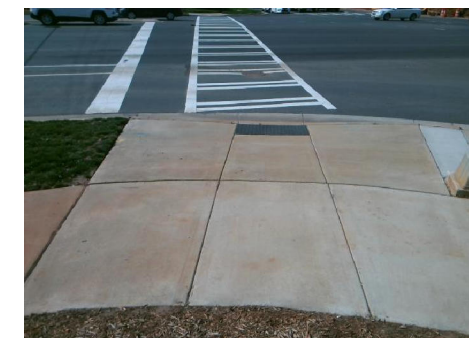
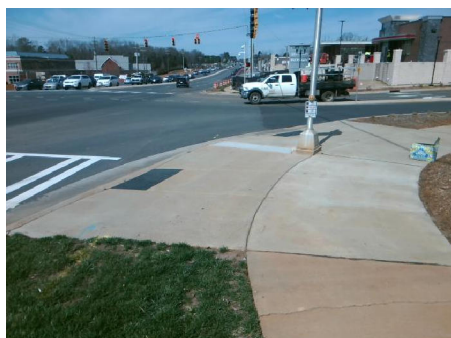
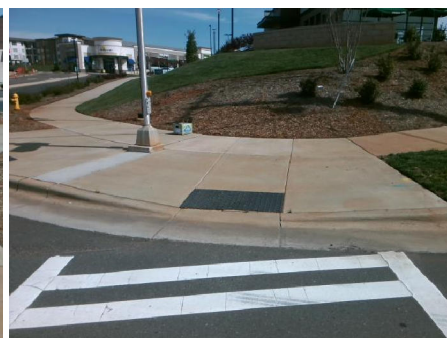
Not Found, R304.5.1, R304.5.3

Compliance	Description	Data	Compliance	Description	Data
N/A	Ramp Length (in)	96.0	Yes	Ramp Slope (%)	7.8
No	Ramp Width (in)	47.5	No	Ramp XSlope (%)	2.9
N/A	Flare Type LT	N/A	N/A	Flare Type RT	N/A
N/A	Flare Slope LT (%)	N/A	N/A	Flare Slope RT (%)	N/A
N/A	Flare Traversable LT?	N/A	N/A	Flare Traversable RT?	N/A
N/A	Landing Length (in)	N/A	N/A	DWS Provided?	N/A
N/A	Landing Width (in)	N/A	N/A	DWS Contrast?	N/A
N/A	Landing Slope (%)	N/A	N/A	DWS Length (in)	N/A
N/A	Landing X Slope (%)	N/A	N/A	DWS Full Width?	N/A
N/A	Landing Curb? (Y/N)	N/A	N/A	DWS Offset (in)	N/A
N/A	Shared Landing?	N/A			
N/A	Gutter Ponding?	N/A	N/A	Gutter Slope (%)	N/A
N/A	Gutter Lip Ht (in)	N/A	N/A	Gutter X Slope (%)	N/A
N/A	Painted X Walk1?	Yes	N/A	Painted X Walk2?	N/A
	X Walk 1 Direction	To W		X Walk 2 Direction	N/A
N/A	X Walk 1 Width (in)	105.0	N/A	X Walk 2 Width (in)	N/A
	X Walk 1 Slope (%)	0.5		X Walk 2 Slope (%)	N/A
	X Walk 1 X Slope (%)	2.4		X Walk 2 X Slope (%)	N/A

N/A	Ramp inside XWalk1?	Yes	N/A	Ramp inside XWalk2?	N/A
	Road Slope (%)	N/A	N/A	Clear Space?	N/A
	Road X Slope (%)	N/A	N/A	Clear Space to XWalk (in)	N/A
N/A	Any Obstructions?	N/A	N/A	Storm Grate/Utility Hazard?	N/A
	Obstruction Type			Storm Grate/Utility Type	
		N/A			N/A
			Yes	Surface Condition? (G/P)	Good

Possible Solutions:

Remove & Replace Entire Ramp.

Total Cost: \$ 1850.00
