# Access Compliance Report

## Public Rights-of-Way

### (Curb Ramps)

Intersection ID: 12877	Main Street: E_5TH_ST	Cross Street: N_MYERS_ST	Location: E
ADA ID: 63A04254CF	Ramp Type: PerpDiag	Initial Pass/Fail: Fail	Overall Compliance: No
			Severity Score: 26.25

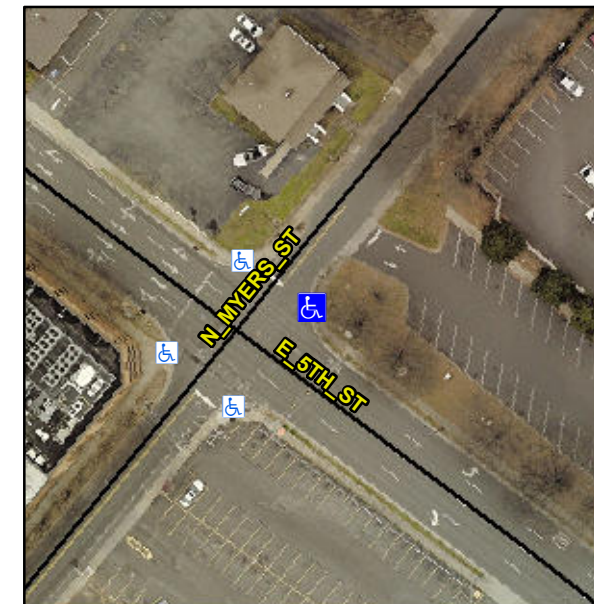
**Not Found, R304.2.2, R304.5.3**

Compliance	Description	Data	Compliance	Description	Data
N/A	Ramp Length (in)	59.0	No	Ramp Slope (%)	12.9
Yes	Ramp Width (in)	48.0	No	Ramp XSlope (%)	4.0
N/A	Flare Type LT	N/A	N/A	Flare Type RT	N/A
N/A	Flare Slope LT (%)	N/A	N/A	Flare Slope RT (%)	N/A
N/A	Flare Traversable LT?	N/A	N/A	Flare Traversable RT?	N/A
N/A	Landing Length (in)	N/A	N/A	DWS Provided?	N/A
N/A	Landing Width (in)	N/A	N/A	DWS Contrast?	N/A
N/A	Landing Slope (%)	N/A	N/A	DWS Length (in)	N/A
N/A	Landing X Slope (%)	N/A	N/A	DWS Full Width?	N/A
N/A	Landing Curb? (Y/N)	N/A	N/A	DWS Offset (in)	N/A
N/A	Shared Landing?	N/A			
N/A	Gutter Ponding?	N/A	N/A	Gutter Slope (%)	N/A
N/A	Gutter Lip Ht (in)	N/A	N/A	Gutter X Slope (%)	N/A
N/A	Painted X Walk1?	No	N/A	Painted X Walk2?	No
	X Walk 1 Direction	To NW		X Walk 2 Direction	To SW
N/A	X Walk 1 Width (in)	N/A	N/A	X Walk 2 Width (in)	N/A
	X Walk 1 Slope (%)	10.2		X Walk 2 Slope (%)	5.3
	X Walk 1 X Slope (%)	1.5		X Walk 2 X Slope (%)	6.7

N/A	Ramp inside XWalk1?	N/A	N/A	Ramp inside XWalk2?	N/A
	Road Slope (%)	2.0	N/A	Clear Space?	N/A
	Road X Slope (%)	8.9	N/A	Clear Space to XWalk (in)	N/A
N/A	Any Obstructions?	N/A	N/A	Storm Grate/Utility Hazard?	N/A
	Obstruction Type			Storm Grate/Utility Type	
		N/A			N/A
			Yes	Surface Condition? (G/P)	Good

**Remove & Replace Curb Ramp With Two New Directional Ramps or Equivalent.**
