Access Compliance Report

Public Rights-of-Way

(Curb Ramps)

Intersection ID: 14479	Main Street: BARNHILL_DR	Cross Street: PINECREST_AV	Location: SE
ADA ID: 63A0BC2BABAA	Ramp Type: Perp	Initial Pass/Fail: Fail	Overall Compliance: No
Severity Score: 33.75			
Codes/Mitigation Info/Possible Solution		Field Measurements/Component Compliance

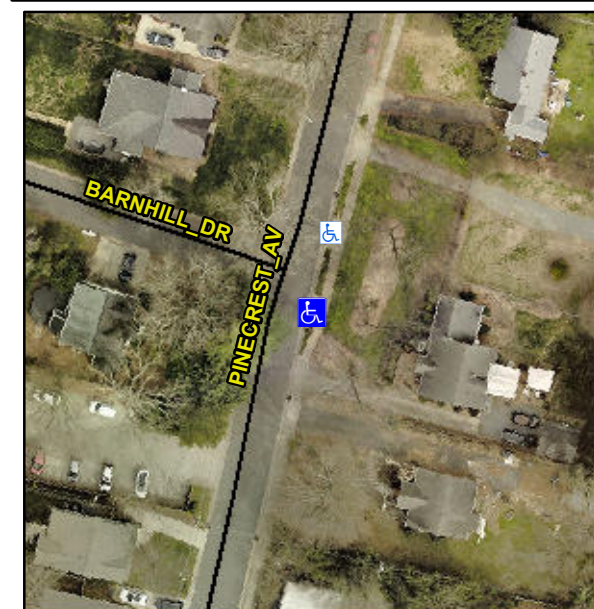
Not Found, R304.5.1, R304.2.2, R304.5.3

Compliance	Description	Data	Compliance	Description	Data
N/A	Ramp Length (in)	48.0	No	Ramp Slope (%)	9.1
No	Ramp Width (in)	47.0	No	Ramp XSlope (%)	6.3
N/A	Flare Type LT	N/A	N/A	Flare Type RT	N/A
N/A	Flare Slope LT (%)	N/A	N/A	Flare Slope RT (%)	N/A
N/A	Flare Traversable LT?	N/A	N/A	Flare Traversable RT?	N/A
N/A	Landing Length (in)	N/A	N/A	DWS Provided?	N/A
N/A	Landing Width (in)	N/A	N/A	DWS Contrast?	N/A
N/A	Landing Slope (%)	N/A	N/A	DWS Length (in)	N/A
N/A	Landing X Slope (%)	N/A	N/A	DWS Full Width?	N/A
N/A	Landing Curb? (Y/N)	N/A	N/A	DWS Offset (in)	N/A
N/A	Shared Landing?	N/A			
N/A	Gutter Ponding?	N/A	N/A	Gutter Slope (%)	N/A
N/A	Gutter Lip Ht (in)	N/A	N/A	Gutter X Slope (%)	N/A
N/A	Painted X Walk1?	No	N/A	Painted X Walk2?	N/A
	X Walk 1 Direction	To W		X Walk 2 Direction	N/A
N/A	X Walk 1 Width (in)	N/A	N/A	X Walk 2 Width (in)	N/A
	X Walk 1 Slope (%)	5.0		X Walk 2 Slope (%)	N/A
	X Walk 1 X Slope (%)	5.3		X Walk 2 X Slope (%)	N/A

N/A	Ramp inside XWalk1?	N/A	N/A	Ramp inside XWalk2?	N/A
	Road Slope (%)	N/A	N/A	Clear Space?	N/A
	Road X Slope (%)	N/A	N/A	Clear Space to XWalk (in)	N/A
N/A	Any Obstructions?	N/A	N/A	Storm Grate/Utility Hazard?	N/A
	Obstruction Type			Storm Grate/Utility Type	
		N/A			N/A
			Yes	Surface Condition? (G/P)	Good

Possible Solutions:

Remove & Replace Entire Ramp.
