Access Compliance Report

Public Rights-of-Way

(Curb Ramps)

Intersection ID: 21312	Main Street: E_ARROWOOD_RD	Cross Street: SOUTH_BV	Location: NW
ADA ID: 63DF52373045	Ramp Type: PerpDiag	Initial Pass/Fail: Fail	Overall Compliance: No
Severity Score: 26.25			
Codes/Mitigation Info/Possible Solution		Field Measurements/Component Compliance

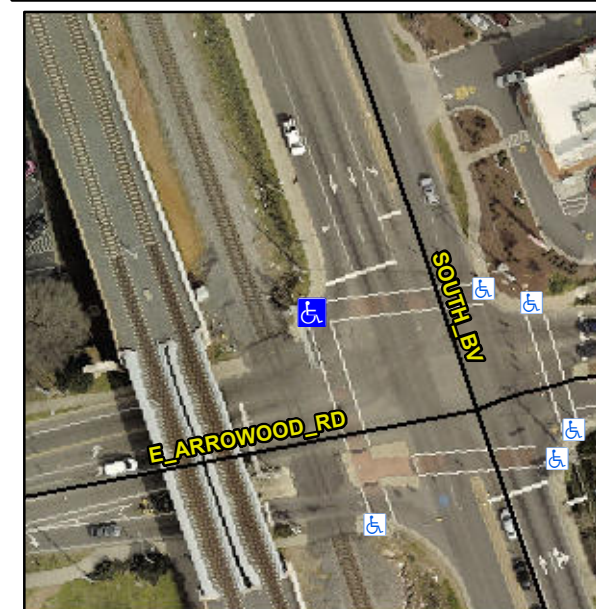
R304.2.2, R304.5.3

Compliance	Description	Data	Compliance	Description	Data
N/A	Ramp Length (in)	48.0	No	Ramp Slope (%)	13.5
Yes	Ramp Width (in)	96.0	No	Ramp XSlope (%)	3.8
N/A	Flare Type LT	N/A	N/A	Flare Type RT	N/A
N/A	Flare Slope LT (%)	N/A	N/A	Flare Slope RT (%)	N/A
N/A	Flare Traversable LT?	N/A	N/A	Flare Traversable RT?	N/A
N/A	Landing Length (in)	N/A	N/A	DWS Provided?	N/A
N/A	Landing Width (in)	N/A	N/A	DWS Contrast?	N/A
N/A	Landing Slope (%)	N/A	N/A	DWS Length (in)	N/A
N/A	Landing X Slope (%)	N/A	N/A	DWS Full Width?	N/A
N/A	Landing Curb? (Y/N)	N/A	N/A	DWS Offset (in)	N/A
N/A	Shared Landing?	N/A			
N/A	Gutter Ponding?	N/A	N/A	Gutter Slope (%)	N/A
N/A	Gutter Lip Ht (in)	N/A	N/A	Gutter X Slope (%)	N/A
N/A	Painted X Walk1?	Yes	N/A	Painted X Walk2?	Yes
	X Walk 1 Direction	To S		X Walk 2 Direction	To E
N/A	X Walk 1 Width (in)	127.0	N/A	X Walk 2 Width (in)	124.0
	X Walk 1 Slope (%)	2.2		X Walk 2 Slope (%)	2.9
	X Walk 1 X Slope (%)	3.6		X Walk 2 X Slope (%)	1.8

N/A	Ramp inside XWalk1?	Yes	N/A	Ramp inside XWalk2?	Yes
	Road Slope (%)	1.9	N/A	Clear Space?	N/A
	Road X Slope (%)	3.6	N/A	Clear Space to XWalk (in)	N/A
N/A	Any Obstructions?	N/A	N/A	Storm Grate/Utility Hazard?	N/A
	Obstruction Type			Storm Grate/Utility Type	
		N/A			N/A
		Yes		Surface Condition? (G/P)	Good

Remove & Replace Curb Ramp With Two New Directional Ramps or Equivalent.
