Access Compliance Report

Public Rights-of-Way

(Curb Ramps)

Intersection ID: 51045	Main Street: PALATINE_LN	Cross Street: KENDALL_DR	Location: NE
ADA ID: 63E08DDA68A7	Ramp Type: Perp	Initial Pass/Fail: Pass	Overall Compliance: No
Severity Score: 5			
Codes/Mitigation Info/Possible Solution		Field Measurements/Component Compliance

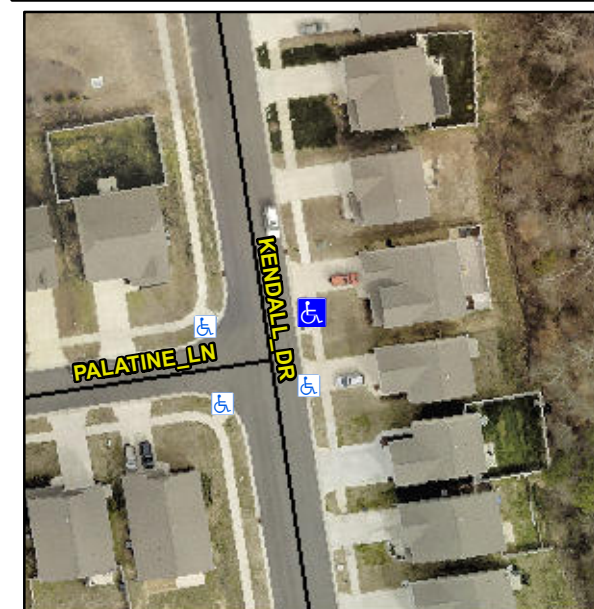
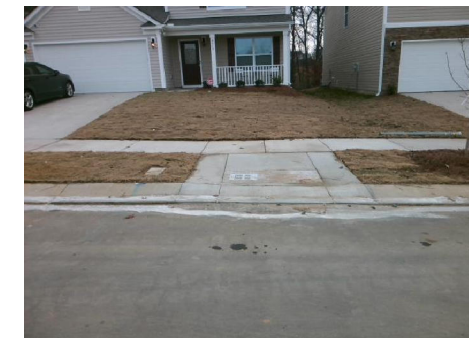
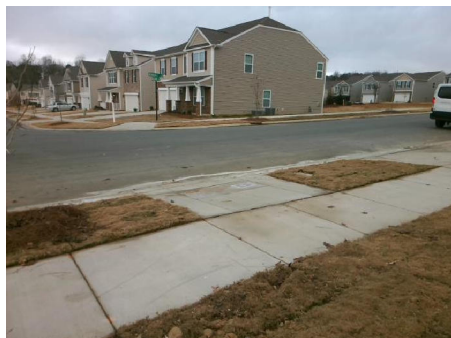
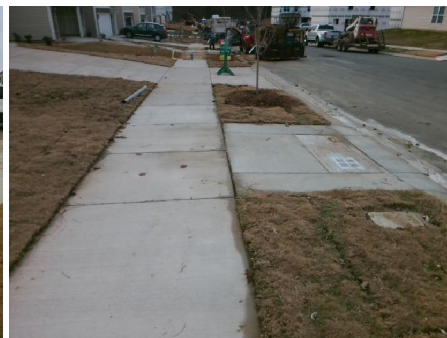
Compliance	Description	Data	Compliance	Description	Data
N/A	Ramp Length (in)	71.5	Yes	Ramp Slope (%)	7.0
Yes	Ramp Width (in)	60.0	Yes	Ramp XSlope (%)	1.6
N/A	Flare Type LT	Sloped	N/A	Flare Type RT	N/A
N/A	Flare Slope LT (%)	7.9	Yes	Flare Slope RT (%)	0.8
N/A	Flare Traversable LT?	Yes	N/A	Flare Traversable RT?	Yes
Yes	Landing Length (in)	59.0	Yes	DWS Provided?	Yes
Yes	Landing Width (in)	60.0	Yes	DWS Contrast?	Yes
Yes	Landing Slope (%)	0.3	Yes	DWS Length (in)	24.0
Yes	Landing X Slope (%)	0.6	Yes	DWS Full Width?	Yes
N/A	Landing Curb? (Y/N)	No	No	DWS Offset (in)	5.0
N/A	Shared Landing?	No			
Yes	Gutter Ponding?	No	No	Gutter Slope (%)	5.9
Yes	Gutter Lip Ht (in)	0.0	No	Gutter X Slope (%)	4.5
N/A	Painted X Walk1?	No	N/A	Painted X Walk2?	N/A
	X Walk 1 Direction	To W		X Walk 2 Direction	N/A
N/A	X Walk 1 Width (in)	N/A	N/A	X Walk 2 Width (in)	N/A
	X Walk 1 Slope (%)	4.0		X Walk 2 Slope (%)	N/A
	X Walk 1 X Slope (%)	3.8		X Walk 2 X Slope (%)	N/A

N/A	Ramp inside XWalk1?	N/A	N/A	Ramp inside XWalk2?	N/A
	Road Slope (%)	N/A	N/A	Clear Space?	Yes
	Road X Slope (%)	N/A	N/A	Clear Space to XWalk (in)	N/A
Yes	Any Obstructions?	No	Yes	Storm Grate/Utility Hazard?	No
	Obstruction Type			Storm Grate/Utility Type	
		N/A			N/A
			Yes	Surface Condition? (G/P)	Good

Possible Solutions:

**Remove & Replace Entire Ramp.
Remove & Replace Gutter.**

**Not Found, R305.2, R304.5.4,
R304.5.3**
