# Access Compliance Report

## Public Rights-of-Way

### (Curb Ramps)

Intersection ID: 50583	Main Street: GRAND_FIR_RD	Cross Street: LONGSTRAW_RD	Location: SE
ADA ID: 63E2AF1B9E8A	Ramp Type: Perp	Initial Pass/Fail: Fail	Overall Compliance: No
Severity Score: 21.25			
Codes/Mitigation Info/Possible Solution		Field Measurements/Component Compliance

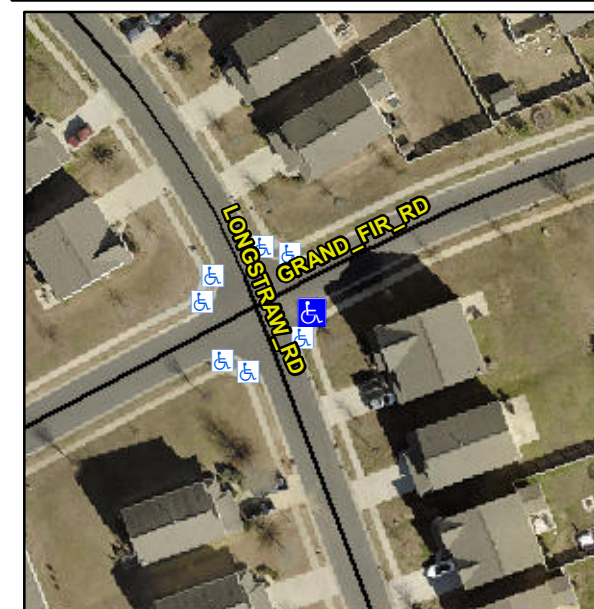
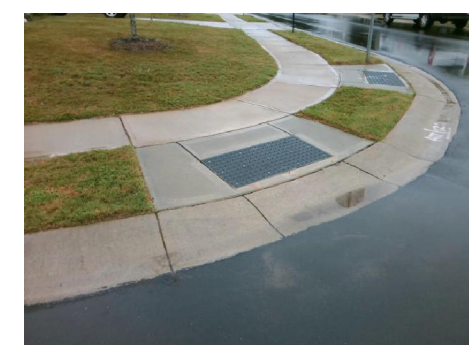
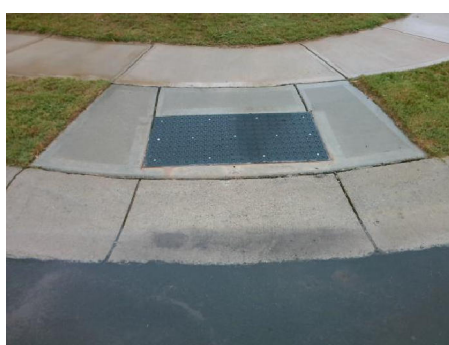
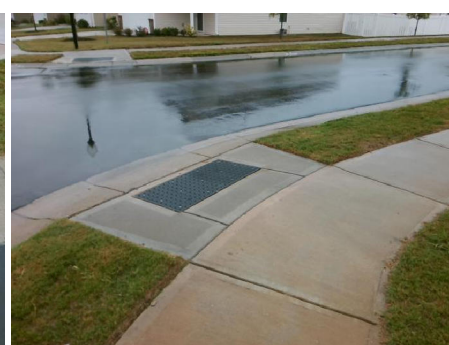
**Not Found, R304.5.1, R304.2.2**

Compliance	Description	Data	Compliance	Description	Data
N/A	Ramp Length (in)	48.0	No	Ramp Slope (%)	11.9
No	Ramp Width (in)	46.0	Yes	Ramp XSlope (%)	1.8
N/A	Flare Type LT	N/A	N/A	Flare Type RT	N/A
N/A	Flare Slope LT (%)	N/A	N/A	Flare Slope RT (%)	N/A
N/A	Flare Traversable LT?	N/A	N/A	Flare Traversable RT?	N/A
N/A	Landing Length (in)	N/A	N/A	DWS Provided?	N/A
N/A	Landing Width (in)	N/A	N/A	DWS Contrast?	N/A
N/A	Landing Slope (%)	N/A	N/A	DWS Length (in)	N/A
N/A	Landing X Slope (%)	N/A	N/A	DWS Full Width?	N/A
N/A	Landing Curb? (Y/N)	N/A	N/A	DWS Offset (in)	N/A
N/A	Shared Landing?	N/A			
N/A	Gutter Ponding?	Yes	N/A	Gutter Slope (%)	N/A
N/A	Gutter Lip Ht (in)	N/A	N/A	Gutter X Slope (%)	N/A
N/A	Painted X Walk1?	No	N/A	Painted X Walk2?	N/A
	X Walk 1 Direction	To N		X Walk 2 Direction	N/A
N/A	X Walk 1 Width (in)	N/A	N/A	X Walk 2 Width (in)	N/A
	X Walk 1 Slope (%)	1.0		X Walk 2 Slope (%)	N/A
	X Walk 1 X Slope (%)	0.5		X Walk 2 X Slope (%)	N/A

N/A	Ramp inside XWalk1?	N/A	N/A	Ramp inside XWalk2?	N/A
	Road Slope (%)	N/A	N/A	Clear Space?	N/A
	Road X Slope (%)	N/A	N/A	Clear Space to XWalk (in)	N/A
N/A	Any Obstructions?	N/A	N/A	Storm Grate/Utility Hazard?	N/A
	Obstruction Type			Storm Grate/Utility Type	
		N/A			N/A
		Yes		Surface Condition? (G/P)	Good

**Remove & Replace Entire Ramp.**

Total Cost: \$ 1850.00
