# Access Compliance Report

## Public Rights-of-Way

### (Curb Ramps)

| Intersection ID: 28526 | Main Street: ROLLINGBROOK_DR | Cross Street: TYVOLA_CENTRE_DR | Location: NW |

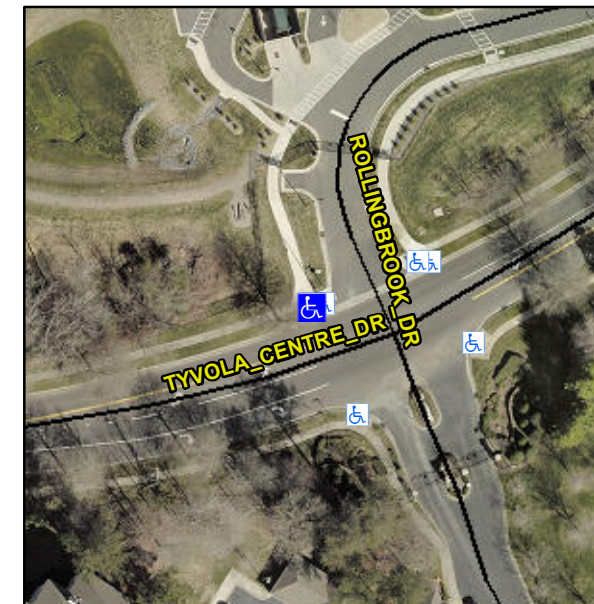
**N/A**

**R304.5.2**

| Compliance | Description | Data | Compliance | Description | Data |
|---|---|---|---|---|---|
| N/A | Ramp Length (in) | 75.0 | No | Grade Break? | No |

**Remove & Replace Entire Ramp.**
