# Access Compliance Report

## Public Rights-of-Way

### (Curb Ramps)

| Intersection ID: 10024219 | Main Street: COVENTRY COURT LN | Cross Street: N/A | Location: NE |

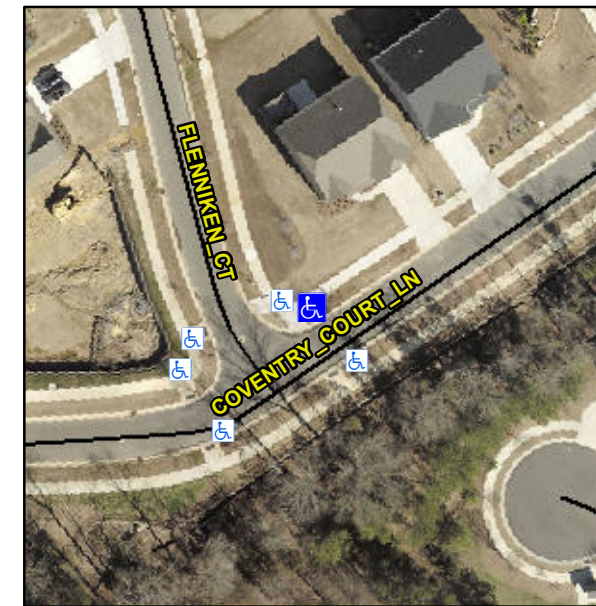
| ADA ID: 63EC0205BE5A | Ramp Type: Perp | Initial Pass/Fail: Pass | Overall Compliance: No |

| Severity Score: 0.25 | | | |

**Not Found, R304.5.3**

| Compliance | Description | Data | Compliance | Description | Data |
|---|---|---|---|---|---|
| Yes | Ramp Width (in) | 48.0 | No | Ramp XSlope (%) | 4.1 |
| No | Landing X Slope (%) | 4.5 | Yes | DWS Full Width? | Yes |
| Yes | Gutter Lip Ht (in) | 0.0 | No | Gutter X Slope (%) | 2.6 |

**Remove & Replace Entire Ramp.  
Remove & Replace Gutter.**

Total Cost: \$ 2600.00
