# Access Compliance Report

## Public Rights-of-Way

### (Curb Ramps)

| Intersection ID: 53924 | Main Street: RORY_GLEN_LN | Cross Street: BRITTONDALE_LN | Location: NW |

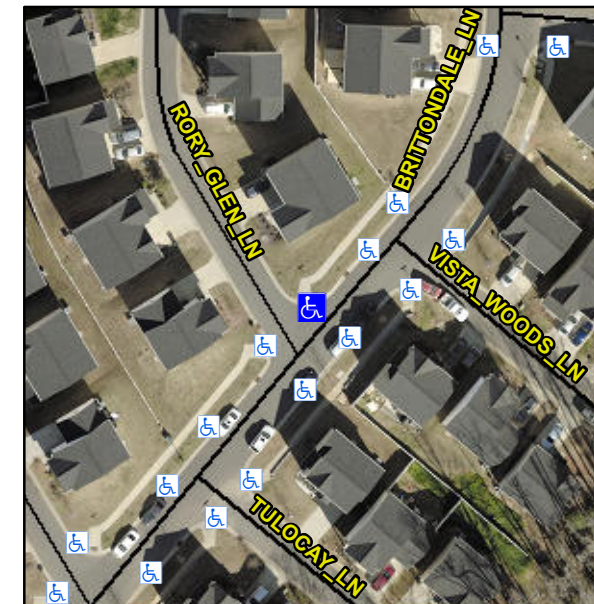
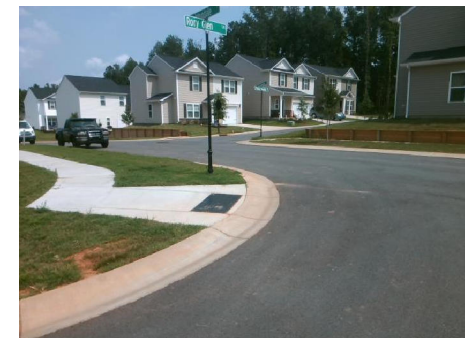
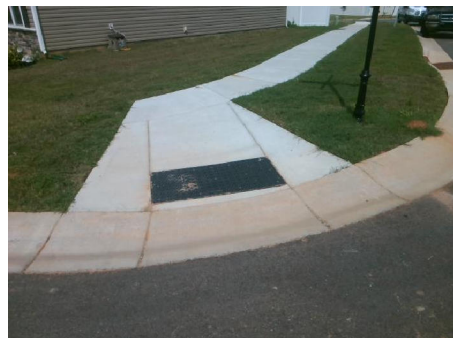
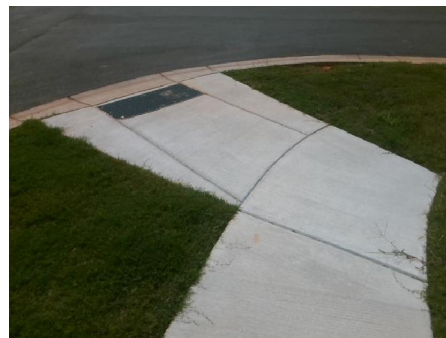
| ADA ID: 63F40910E9ED | Ramp Type: BlendTrans1 | Initial Pass/Fail: Fail | Overall Compliance: No |

**NO LT SW**

**Not Found, R304.5.1, R304.5.3**

| Compliance | Description | Data | Compliance | Description | Data |
|---|---|---|---|---|---|
| No | Ramp Width (in) | 47.5 | No | BlendTrans XSlope (%) | 5.0 |
| | | | No | Curb Slope (%) | 6.5 |

**Remove & Replace Curb Ramp With Two New Directional Ramps or Equivalent.**

Total Cost: \$ 3200.00
