# Access Compliance Report

## Public Rights-of-Way

### (Curb Ramps)

Intersection ID: 28626	Main Street: MILLERS_CREEK_LN	Cross Street: STUARTS_DRAFT_CT	Location: SE
ADA ID: 63F5ACD6BF5E	Ramp Type: PerpDiag	Initial Pass/Fail: Fail	Overall Compliance: No
Severity Score: 12.5			
Codes/Mitigation Info/Possible Solution		Field Measurements/Component Compliance

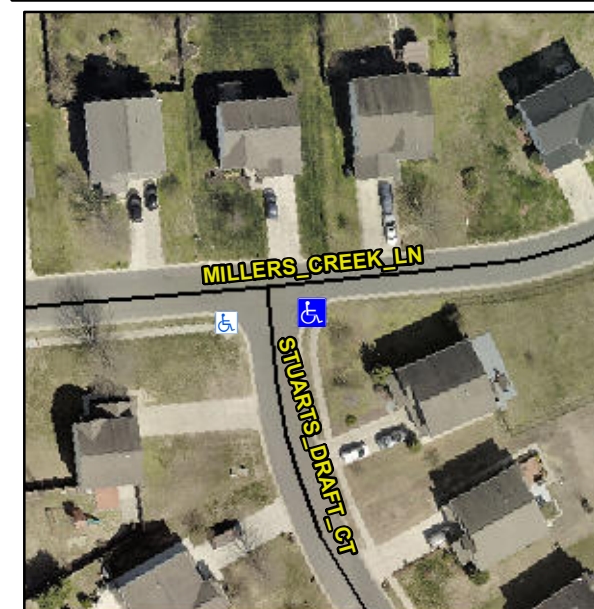
Compliance	Description	Data	Compliance	Description	Data
N/A	Ramp Length (in)	49.5	No	Ramp Slope (%)	9.1
Yes	Ramp Width (in)	52.0	Yes	Ramp XSlope (%)	1.8
N/A	Flare Type LT	N/A	N/A	Flare Type RT	N/A
N/A	Flare Slope LT (%)	N/A	N/A	Flare Slope RT (%)	N/A
N/A	Flare Traversable LT?	N/A	N/A	Flare Traversable RT?	N/A
N/A	Landing Length (in)	N/A	N/A	DWS Provided?	N/A
N/A	Landing Width (in)	N/A	N/A	DWS Contrast?	N/A
N/A	Landing Slope (%)	N/A	N/A	DWS Length (in)	N/A
N/A	Landing X Slope (%)	N/A	N/A	DWS Full Width?	N/A
N/A	Landing Curb? (Y/N)	N/A	N/A	DWS Offset (in)	N/A
N/A	Shared Landing?	N/A			
N/A	Gutter Ponding?	N/A	N/A	Gutter Slope (%)	N/A
N/A	Gutter Lip Ht (in)	N/A	N/A	Gutter X Slope (%)	N/A
N/A	Painted X Walk1?	No	N/A	Painted X Walk2?	No
	X Walk 1 Direction	To N		X Walk 2 Direction	To W
N/A	X Walk 1 Width (in)	N/A	N/A	X Walk 2 Width (in)	N/A
	X Walk 1 Slope (%)	0.2		X Walk 2 Slope (%)	2.3
	X Walk 1 X Slope (%)	2.3		X Walk 2 X Slope (%)	1.2

N/A	Ramp inside XWalk1?	N/A	N/A	Ramp inside XWalk2?	N/A
	Road Slope (%)	0.5	N/A	Clear Space?	N/A
	Road X Slope (%)	3.0	N/A	Clear Space to XWalk (in)	N/A
N/A	Any Obstructions?	N/A	N/A	Storm Grate/Utility Hazard?	N/A
	Obstruction Type			Storm Grate/Utility Type	
		N/A			N/A
			Yes	Surface Condition? (G/P)	Good

**Remove & Replace Curb Ramp With Two New Directional Ramps or Equivalent.**
