Access Compliance Report Public Rights-of-Way (Curb Ramps)

Intersection ID: N/A Main Street: BISCAYNE_DR Cross Street: N/A Location: NE Overall Compliance: No **Severity Score:** ADA ID: 63F622B9EB86 Ramp Type: Directional1 Initial Pass/Fail: Fail 25

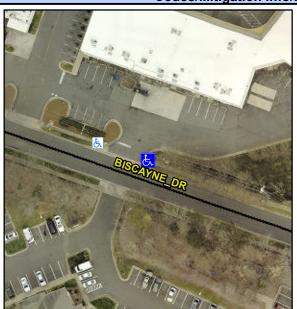
Field Measurements/Component Compliance					
Comp	liance Description	Data	Comp	liance Description	Data
N/A	Ramp Length (in)	117.0	N/A	Grade Break?	N/A
Yes	Ramp Width (in)	48.0	N/A	Grade Break Slope (%)	0.0
No	Ramp Slope (%)	9.9	N/A	Grade Break XSlope (%)	0.0
No	Ramp XSlope (%)	5.4			
N/A	Flare Type LT	N/A	N/A	Flare Type RT	N/A
N/A	Flare Slope LT (%)	N/A	N/A	Flare Slope RT (%)	0.0
N/A	Flare Traversable LT?	N/A	N/A	Flare Traversable RT?	N/A
N/A	Landing Length (in)	0.0	N/A	DWS Provided?	N/A
N/A	Landing Width (in)	0.0	N/A	DWS Contrast?	N/A
N/A	Landing Slope (%)	0.0	N/A	DWS Length (in)	N/A
N/A	Landing X Slope (%)	0.0	N/A	DWS Full Width?	N/A
N/A	Landing Curb? (Y/N)	N/A	N/A	DWS Offset LT (in)	N/A
N/A	Shared Landing?	N/A	N/A	DWS Offset RT (in)	N/A
N/A	Gutter Ponding?	0.0	N/A	Gutter Slope (%)	N/A
N/A	Gutter Lip Ht (in)	0.0	N/A	Gutter X Slope (%)	N/A
N/A	Painted X Walk1?	No		Road Slope (%)	8.4
	X Walk 1 Direction	To W		Road X Slope (%)	0.0

X Walk 1 Width (in)	N/A		Clear Space?	N/A
	X Walk 1 Slope (%)	8.4	N/A	Clear Space to XWalk (in)	N/A
	X Walk 1 X Slope (%)	0.0	N/A	Storm Grate/Utility Hazard?	N/A
N/A	Ramp inside XWalk1?	N/A		Storm Grate/Utility Type	
N/A	Any Obstructions?	N/A			N/A
	Obstruction Type		Yes	Surface Condition? (G/P)	Good
		N/A	N/A	Curb Slope (%)	12.9

Possible Solution	
Possible Solutions:	Coi
Remove & Replace Entire Ramp.	N/A
·	Yes
	No
	No
	N/A
	N/A
Surveyor Notes:	N/A
N/A	N/A
	N/A
	N/A
	N/A
PROW/ADA:	N/A
R304.2.2, R304.5.3	N/A
,	N/A
	N/A
	N/A

Total Cost:	\$ 1600.00
