Access Compliance Report

Public Rights-of-Way

(Curb Ramps)

Intersection ID: 10053	Main Street: BURTON_ST	Cross Street: FONTANA_AV	Location: SE
ADA ID: 63FFB1174412	Ramp Type: Perp	Initial Pass/Fail: Fail	Overall Compliance: No
Severity Score: 25			
Codes/Mitigation Info/Possible Solution		Field Measurements/Component Compliance

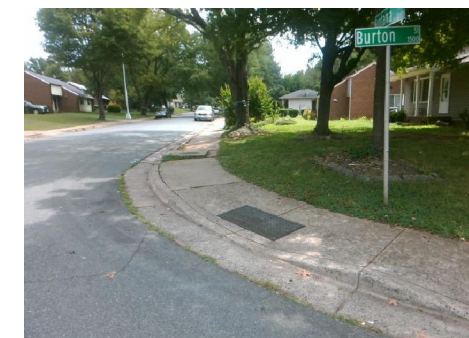
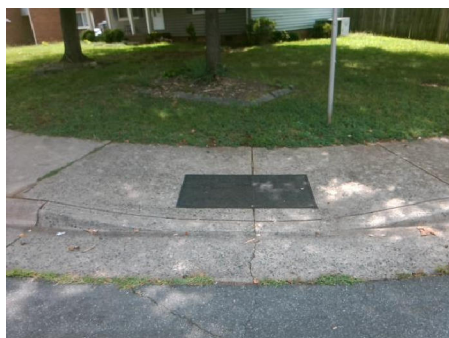
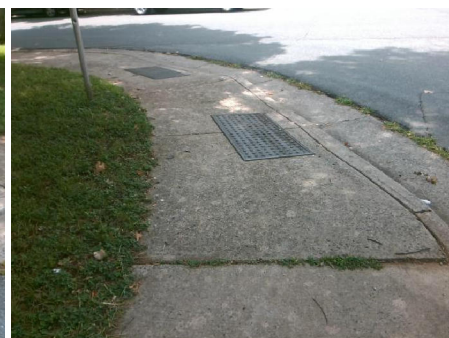
Not Found, R304.2.2, R304.5.3

Compliance	Description	Data	Compliance	Description	Data
N/A	Ramp Length (in)	59.0	No	Ramp Slope (%)	9.6
Yes	Ramp Width (in)	48.0	No	Ramp XSlope (%)	6.2
N/A	Flare Type LT	N/A	N/A	Flare Type RT	N/A
N/A	Flare Slope LT (%)	N/A	N/A	Flare Slope RT (%)	N/A
N/A	Flare Traversable LT?	N/A	N/A	Flare Traversable RT?	N/A
N/A	Landing Length (in)	N/A	N/A	DWS Provided?	N/A
N/A	Landing Width (in)	N/A	N/A	DWS Contrast?	N/A
N/A	Landing Slope (%)	N/A	N/A	DWS Length (in)	N/A
N/A	Landing X Slope (%)	N/A	N/A	DWS Full Width?	N/A
N/A	Landing Curb? (Y/N)	N/A	N/A	DWS Offset (in)	N/A
N/A	Shared Landing?	N/A			
N/A	Gutter Ponding?	N/A	N/A	Gutter Slope (%)	N/A
N/A	Gutter Lip Ht (in)	1.5	N/A	Gutter X Slope (%)	N/A
N/A	Painted X Walk1?	No	N/A	Painted X Walk2?	N/A
	X Walk 1 Direction	To N		X Walk 2 Direction	N/A
N/A	X Walk 1 Width (in)	N/A	N/A	X Walk 2 Width (in)	N/A
	X Walk 1 Slope (%)	1.5		X Walk 2 Slope (%)	N/A
	X Walk 1 X Slope (%)	2.7		X Walk 2 X Slope (%)	N/A

N/A	Ramp inside XWalk1?	N/A	N/A	Ramp inside XWalk2?	N/A
	Road Slope (%)	N/A	N/A	Clear Space?	N/A
	Road X Slope (%)	N/A	N/A	Clear Space to XWalk (in)	N/A
N/A	Any Obstructions?	N/A	N/A	Storm Grate/Utility Hazard?	N/A
	Obstruction Type			Storm Grate/Utility Type	
		N/A			N/A
			Yes	Surface Condition? (G/P)	Good

Possible Solutions:

Remove & Replace Entire Ramp.
