Access Compliance Report

Public Rights-of-Way

(Curb Ramps)

Intersection ID: 26932	Main Street: CARLESBROOKE_TR	Cross Street: WYNYATES_LN	Location: NE
ADA ID: 6404599184E6	Ramp Type: Perp	Initial Pass/Fail: Fail	Overall Compliance: No
Severity Score: 22.5			
Codes/Mitigation Info/Possible Solution		Field Measurements/Component Compliance

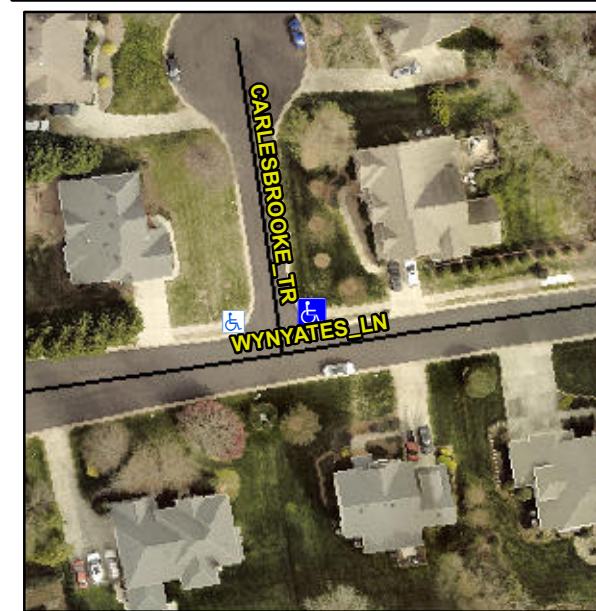
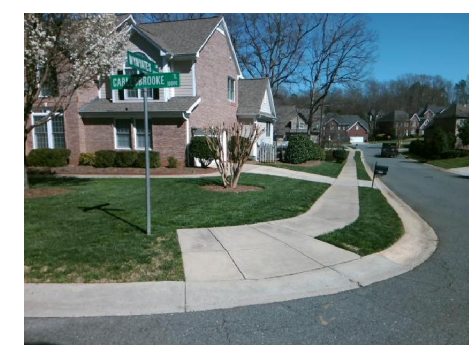
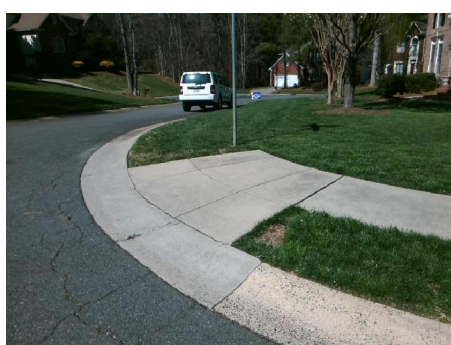
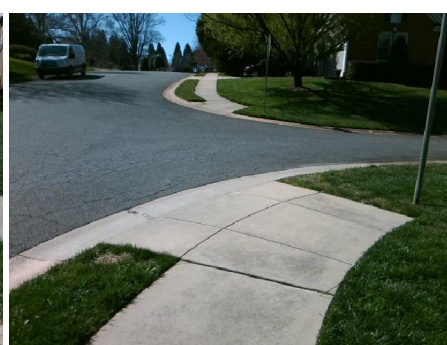
R304.5.1, R304.2.2, R304.5.3

Compliance	Description	Data	Compliance	Description	Data
N/A	Ramp Length (in)	35.0	No	Ramp Slope (%)	8.8
No	Ramp Width (in)	41.0	No	Ramp XSlope (%)	4.1
N/A	Flare Type LT	N/A	N/A	Flare Type RT	N/A
N/A	Flare Slope LT (%)	N/A	N/A	Flare Slope RT (%)	N/A
N/A	Flare Traversable LT?	N/A	N/A	Flare Traversable RT?	N/A
N/A	Landing Length (in)	N/A	N/A	DWS Provided?	N/A
N/A	Landing Width (in)	N/A	N/A	DWS Contrast?	N/A
N/A	Landing Slope (%)	N/A	N/A	DWS Length (in)	N/A
N/A	Landing X Slope (%)	N/A	N/A	DWS Full Width?	N/A
N/A	Landing Curb? (Y/N)	N/A	N/A	DWS Offset (in)	N/A
N/A	Shared Landing?	N/A			
N/A	Gutter Ponding?	N/A	N/A	Gutter Slope (%)	N/A
N/A	Gutter Lip Ht (in)	N/A	N/A	Gutter X Slope (%)	N/A
N/A	Painted X Walk1?	No	N/A	Painted X Walk2?	N/A
	X Walk 1 Direction	To W		X Walk 2 Direction	N/A
N/A	X Walk 1 Width (in)	N/A	N/A	X Walk 2 Width (in)	N/A
	X Walk 1 Slope (%)	7.2		X Walk 2 Slope (%)	N/A
	X Walk 1 X Slope (%)	1.4		X Walk 2 X Slope (%)	N/A

N/A	Ramp inside XWalk1?	N/A	N/A	Ramp inside XWalk2?	N/A
	Road Slope (%)	N/A	N/A	Clear Space?	N/A
	Road X Slope (%)	N/A	N/A	Clear Space to XWalk (in)	N/A
N/A	Any Obstructions?	N/A	N/A	Storm Grate/Utility Hazard?	N/A
	Obstruction Type			Storm Grate/Utility Type	
		N/A			N/A
			Yes	Surface Condition? (G/P)	Good

Possible Solutions:

Remove & Replace Entire Ramp.
