Access Compliance Report

Public Rights-of-Way (Curb Ramps)

Intersection ID: 3539	Main Street: HARRIS_CORNERS_PY	Cross Street: MAPLE_VIEW_LN	Location: NW
ADA ID: 640F2896462E	Ramp Type: Perp	Initial Pass/Fail: Fail	Overall Compliance: No
		Severity Score: 12.5

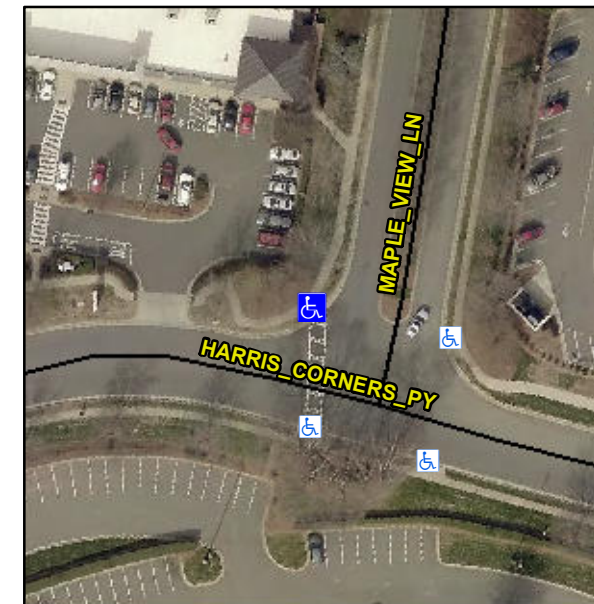
Compliance	Description	Data	Compliance	Description	Data
N/A	Ramp Length (in)	48.5	No	Ramp Slope (%)	8.4
Yes	Ramp Width (in)	48.0	Yes	Ramp XSlope (%)	1.1
N/A	Flare Type LT	N/A	N/A	Flare Type RT	N/A
N/A	Flare Slope LT (%)	N/A	N/A	Flare Slope RT (%)	N/A
N/A	Flare Traversable LT?	N/A	N/A	Flare Traversable RT?	N/A
N/A	Landing Length (in)	N/A	N/A	DWS Provided?	N/A
N/A	Landing Width (in)	N/A	N/A	DWS Contrast?	N/A
N/A	Landing Slope (%)	N/A	N/A	DWS Length (in)	N/A
N/A	Landing X Slope (%)	N/A	N/A	DWS Full Width?	N/A
N/A	Landing Curb? (Y/N)	N/A	N/A	DWS Offset (in)	N/A
N/A	Shared Landing?	N/A			
N/A	Gutter Ponding?	N/A	N/A	Gutter Slope (%)	N/A
N/A	Gutter Lip Ht (in)	N/A	N/A	Gutter X Slope (%)	N/A
N/A	Painted X Walk1?	Yes	N/A	Painted X Walk2?	N/A
	X Walk 1 Direction	To S		X Walk 2 Direction	N/A
N/A	X Walk 1 Width (in)	85.0	N/A	X Walk 2 Width (in)	N/A
	X Walk 1 Slope (%)	0.1		X Walk 2 Slope (%)	N/A
	X Walk 1 X Slope (%)	0.1		X Walk 2 X Slope (%)	N/A

N/A	Ramp inside XWalk1?	Yes	N/A	Ramp inside XWalk2?	N/A
	Road Slope (%)	N/A	N/A	Clear Space?	N/A
	Road X Slope (%)	N/A	N/A	Clear Space to XWalk (in)	N/A
N/A	Any Obstructions?	N/A	N/A	Storm Grate/Utility Hazard?	N/A
	Obstruction Type			Storm Grate/Utility Type	
		N/A			N/A
		Yes		Surface Condition? (G/P)	Good

Remove & Replace Entire Ramp.

R304.2.2

\$ 1850.00
