Access Compliance Report

Public Rights-of-Way

(Curb Ramps)

Intersection ID: 29966	Main Street: PANOS_DR	Cross Street: W_W_T_HARRIS_BV	Location: NW
ADA ID: 6411E30D83A3	Ramp Type: Perp	Initial Pass/Fail: Fail	Overall Compliance: No
		Severity Score: 1.25

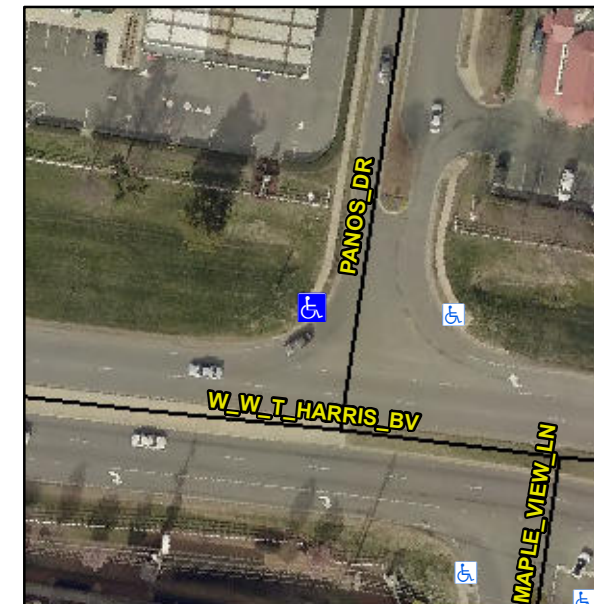
Compliance	Description	Data	Compliance	Description	Data
N/A	Ramp Length (in)	52.5	Yes	Ramp Slope (%)	6.4
Yes	Ramp Width (in)	49.0	No	Ramp XSlope (%)	3.0
N/A	Flare Type LT	N/A	N/A	Flare Type RT	N/A
N/A	Flare Slope LT (%)	N/A	N/A	Flare Slope RT (%)	N/A
N/A	Flare Traversable LT?	N/A	N/A	Flare Traversable RT?	N/A
N/A	Landing Length (in)	N/A	N/A	DWS Provided?	N/A
N/A	Landing Width (in)	N/A	N/A	DWS Contrast?	N/A
N/A	Landing Slope (%)	N/A	N/A	DWS Length (in)	N/A
N/A	Landing X Slope (%)	N/A	N/A	DWS Full Width?	N/A
N/A	Landing Curb? (Y/N)	N/A	N/A	DWS Offset (in)	N/A
N/A	Shared Landing?	N/A			
N/A	Gutter Ponding?	N/A	N/A	Gutter Slope (%)	N/A
N/A	Gutter Lip Ht (in)	N/A	N/A	Gutter X Slope (%)	N/A
N/A	Painted X Walk1?	No	N/A	Painted X Walk2?	N/A
	X Walk 1 Direction	To E		X Walk 2 Direction	N/A
N/A	X Walk 1 Width (in)	N/A	N/A	X Walk 2 Width (in)	N/A
	X Walk 1 Slope (%)	0.8		X Walk 2 Slope (%)	N/A
	X Walk 1 X Slope (%)	5.2		X Walk 2 X Slope (%)	N/A

N/A	Ramp inside XWalk1?	N/A	N/A	Ramp inside XWalk2?	N/A
	Road Slope (%)	N/A	N/A	Clear Space?	N/A
	Road X Slope (%)	N/A	N/A	Clear Space to XWalk (in)	N/A
N/A	Any Obstructions?	N/A	N/A	Storm Grate/Utility Hazard?	N/A
	Obstruction Type			Storm Grate/Utility Type	
		N/A			N/A
			Yes	Surface Condition? (G/P)	Good

Possible Solutions:

Remove & Replace Entire Ramp.

PROW/ADA:

R304.5.3
