## Access Compliance Report Public Rights-of-Way (Curb Ramps)

Intersection ID: 11271 Main Street: CATAWBA\_AV Cross Street: PEGRAM\_ST Location: SE

ADA ID: 6414EC41D11B Ramp Type: Perp Initial Pass/Fail: Fail Overall Compliance: No Severity Score: 21.25

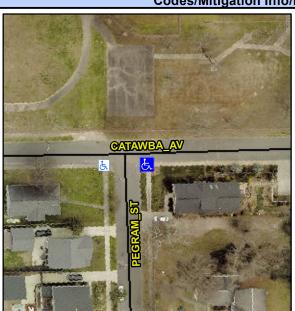
Comp	oliance Description	Data	ta Compliance Des		otion	Data
N/A	Ramp Length (in)	65.0	No	Ramp Slope (	%)	9.2
No	Ramp Width (in)	45.5	Yes	Ramp XSlope	(%)	0.2
N/A	Flare Type LT	N/A	N/A	Flare Type RT	-	N/A
N/A	Flare Slope LT (%)	N/A	N/A	Flare Slope R	T (%)	N/A
N/A	Flare Traversable LT?	N/A	N/A	Flare Traversa	able RT?	N/A
N/A	Landing Length (in)	N/A	N/A	DWS Provided	d?	N/A
N/A	Landing Width (in)	N/A	N/A	DWS Contras	t?	N/A
N/A	Landing Slope (%)	N/A	N/A	DWS Length (	(in)	N/A
N/A	Landing X Slope (%)	N/A	N/A	DWS Full Wid	th?	N/A
N/A	Landing Curb? (Y/N)	N/A	N/A	DWS Offset (i	n)	N/A
N/A	Shared Landing?	N/A				
N/A	Gutter Ponding?	N/A	N/A	Gutter Slope (	(%)	N/A
N/A	Gutter Lip Ht (in)	0.5	N/A	Gutter X Slope	e (%)	N/A
N/A	Painted X Walk1?	No	N/A	Painted X Wa	lk2?	N/A
	X Walk 1 Direction	To W		X Walk 2 Dire	ction	N/A
N/A	X Walk 1 Width (in)	N/A	N/A	X Walk 2 Widt	th (in)	N/A
	X Walk 1 Slope (%)	1.3		X Walk 2 Slop	e (%)	N/A

X Walk 1 X Slope (%)	3.2		X Walk 2 X Sl	ope (%)	N/A
N/A	Ramp inside XWalk1?	N/A	N/A	Ramp inside >	(Walk2?	N/A
	Road Slope (%)	N/A	N/A	Clear Space?		N/A
	Road X Slope (%)	N/A	N/A	Clear Space to	o XWalk (in)	N/A
N/A	Any Obstructions?	N/A	N/A	Storm Grate/U	Itility Hazard?	N/A
	Obstruction Type			Storm Grate/U	Jtility Type	
		N/A				N/A

School	Possible Solutions:
4	Remove & Replace Entire Ramp.
100	
1	
Sec.	
130	
100	Surveyor Notes:
9	N/A
9	
9	DDOW/ADA.
	PROW/ADA:
M. 15	Not Found, R304.5.1, R304.2.2
Sections

Total Cost: \$ 1850.00
