# Access Compliance Report

## Public Rights-of-Way

### (Curb Ramps)

Intersection ID: 11991	Main Street: ALLEGHANY_ST	Cross Street: HAVELOCK_AV	Location: SE
ADA ID: 6419A559C785	Ramp Type: Perp	Initial Pass/Fail: Fail	Overall Compliance: No
Severity Score: 8.75			
Codes/Mitigation Info/Possible Solution		Field Measurements/Component Compliance

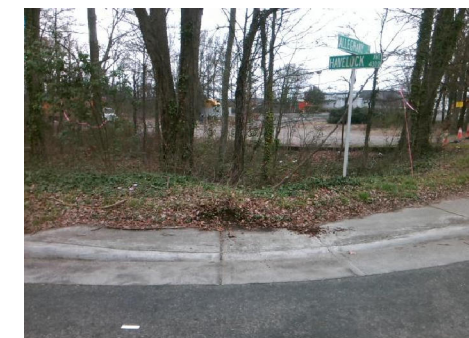
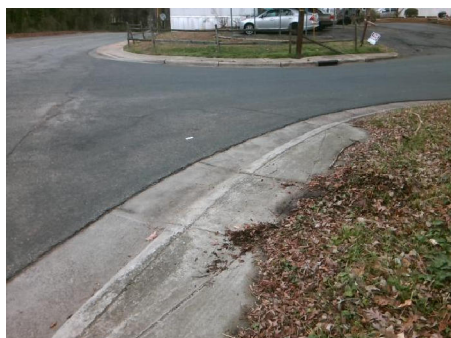
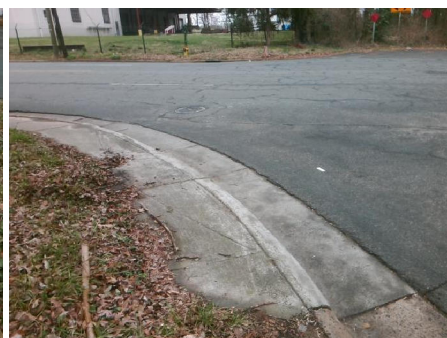
**Not Found, R304.5.1**

Compliance	Description	Data	Compliance	Description	Data
N/A	Ramp Length (in)	48.0	Yes	Ramp Slope (%)	5.2
No	Ramp Width (in)	46.0	Yes	Ramp XSlope (%)	1.5
N/A	Flare Type LT	N/A	N/A	Flare Type RT	N/A
N/A	Flare Slope LT (%)	N/A	N/A	Flare Slope RT (%)	N/A
N/A	Flare Traversable LT?	N/A	N/A	Flare Traversable RT?	N/A
N/A	Landing Length (in)	N/A	N/A	DWS Provided?	N/A
N/A	Landing Width (in)	N/A	N/A	DWS Contrast?	N/A
N/A	Landing Slope (%)	N/A	N/A	DWS Length (in)	N/A
N/A	Landing X Slope (%)	N/A	N/A	DWS Full Width?	N/A
N/A	Landing Curb? (Y/N)	N/A	N/A	DWS Offset (in)	N/A
N/A	Shared Landing?	N/A			
N/A	Gutter Ponding?	N/A	N/A	Gutter Slope (%)	N/A
N/A	Gutter Lip Ht (in)	N/A	N/A	Gutter X Slope (%)	N/A
N/A	Painted X Walk1?	No	N/A	Painted X Walk2?	N/A
	X Walk 1 Direction	To N		X Walk 2 Direction	N/A
N/A	X Walk 1 Width (in)	N/A	N/A	X Walk 2 Width (in)	N/A
	X Walk 1 Slope (%)	0.3		X Walk 2 Slope (%)	N/A
	X Walk 1 X Slope (%)	0.8		X Walk 2 X Slope (%)	N/A

N/A	Ramp inside XWalk1?	N/A	N/A	Ramp inside XWalk2?	N/A
	Road Slope (%)	N/A	N/A	Clear Space?	N/A
	Road X Slope (%)	N/A	N/A	Clear Space to XWalk (in)	N/A
N/A	Any Obstructions?	N/A	N/A	Storm Grate/Utility Hazard?	N/A
	Obstruction Type			Storm Grate/Utility Type	
		N/A			N/A
		Yes		Surface Condition? (G/P)	Good

**Remove & Replace Entire Ramp.**
