Access Compliance Report

Public Rights-of-Way

(Curb Ramps)

Intersection ID: 5774	Main Street: BLACK WALNUT LN	Cross Street: NEVIN RD	Location: S
ADA ID: 6421845140DA	Ramp Type: Perp	Initial Pass/Fail: Fail	Overall Compliance: No
Severity Score: 33.75			
Codes/Mitigation Info/Possible Solution		Field Measurements/Component Compliance

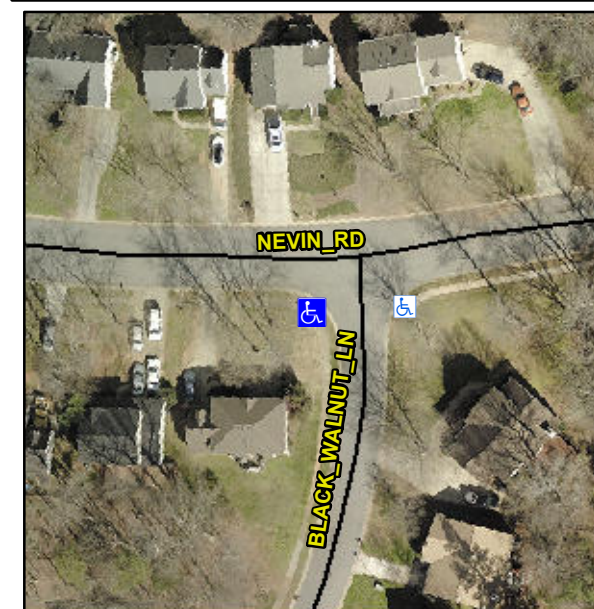
Not Found, R304.5.1, R304.5.3

Compliance	Description	Data	Compliance	Description	Data
N/A	Ramp Length (in)	94.0	Yes	Ramp Slope (%)	6.3
No	Ramp Width (in)	47.0	No	Ramp XSlope (%)	11.4
N/A	Flare Type LT	N/A	N/A	Flare Type RT	N/A
N/A	Flare Slope LT (%)	N/A	N/A	Flare Slope RT (%)	N/A
N/A	Flare Traversable LT?	N/A	N/A	Flare Traversable RT?	N/A
N/A	Landing Length (in)	N/A	N/A	DWS Provided?	N/A
N/A	Landing Width (in)	N/A	N/A	DWS Contrast?	N/A
N/A	Landing Slope (%)	N/A	N/A	DWS Length (in)	N/A
N/A	Landing X Slope (%)	N/A	N/A	DWS Full Width?	N/A
N/A	Landing Curb? (Y/N)	N/A	N/A	DWS Offset (in)	N/A
N/A	Shared Landing?	N/A			
N/A	Gutter Ponding?	N/A	N/A	Gutter Slope (%)	N/A
N/A	Gutter Lip Ht (in)	1.5	N/A	Gutter X Slope (%)	N/A
N/A	Painted X Walk1?	No	N/A	Painted X Walk2?	N/A
	X Walk 1 Direction	To NE		X Walk 2 Direction	N/A
N/A	X Walk 1 Width (in)	N/A	N/A	X Walk 2 Width (in)	N/A
	X Walk 1 Slope (%)	4.4		X Walk 2 Slope (%)	N/A
	X Walk 1 X Slope (%)	6.3		X Walk 2 X Slope (%)	N/A

N/A	Ramp inside XWalk1?	N/A	N/A	Ramp inside XWalk2?	N/A
	Road Slope (%)	N/A	N/A	Clear Space?	N/A
	Road X Slope (%)	N/A	N/A	Clear Space to XWalk (in)	N/A
N/A	Any Obstructions?	N/A	N/A	Storm Grate/Utility Hazard?	N/A
	Obstruction Type			Storm Grate/Utility Type	
		N/A			N/A
			Yes	Surface Condition? (G/P)	Good

Possible Solutions:

Remove & Replace Entire Ramp.
