Access Compliance Report Public Rights-of-Way (Curb Ramps)

Intersection ID: 10024956 Main Street: DISTRICT_SOUTH_DR Cross Street: N/A Location: S

ADA ID: 6433FF22B02A Ramp Type: Para Initial Pass/Fail: Fail Overall Compliance: No Severity Score: 12.5

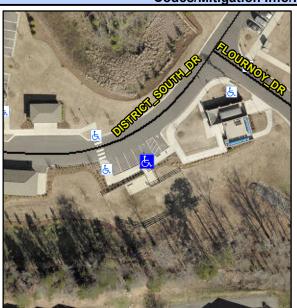
Field Measurements/Component Compliance								
Comp	liance Description	Data	Comp	liance Description	Data			
N/A	Ramp Length LT (in)	69.5	N/A	Ramp Length RT (in)	70.0			
Yes	Ramp Width LT (in)	89.0	Yes	Ramp Width RT (in)	89.0			
No	Ramp Slope LT (%)	8.7	No	Ramp Slope RT (%)	10.1			
Yes	Ramp XSlope LT (%)	1.6	Yes	Ramp XSlope RT (%)	0.7			
N/A	Landing Length (in)	N/A	N/A	DWS Provided?	N/A			
N/A	Landing Width (in)	N/A	N/A	DWS Contrast?	N/A			
N/A	Landing Slope (%)	N/A	N/A	DWS Length (in)	N/A			
N/A	Landing X Slope (%)	N/A	N/A	DWS Full Width?	N/A			
N/A	Landing Curb? (Y/N)	N/A	N/A	DWS Offset (in)	N/A			
N/A	Shared Landing?	N/A						
N/A	Gutter Ponding?	N/A	N/A	Gutter Slope (%)	N/A			
N/A	Gutter Lip Ht (in)	N/A	N/A	Gutter X Slope (%)	N/A			
N/A	Painted X Walk1?	No	N/A	Painted X Walk2?	N/A			
	X Walk 1 Direction	To N		X Walk 2 Direction	N/A			
N/A	X Walk 1 Width (in)	N/A	N/A	X Walk 2 Width (in)	N/A			
	X Walk 1 Slope (%)	0.1		X Walk 2 Slope (%)	N/A

Possible Solution					
Possible Solutions:					
Remove & Replace Entire Ramp.					
Surveyor Notes:					
N/A					
PROW/ADA:					
R304.3.2
