# Access Compliance Report

## Public Rights-of-Way

### (Curb Ramps)

| Intersection ID: 48474 | Main Street: AUTUMN_OAK_DR | Cross Street: WONDERING_OAK_LN | Location: SE |

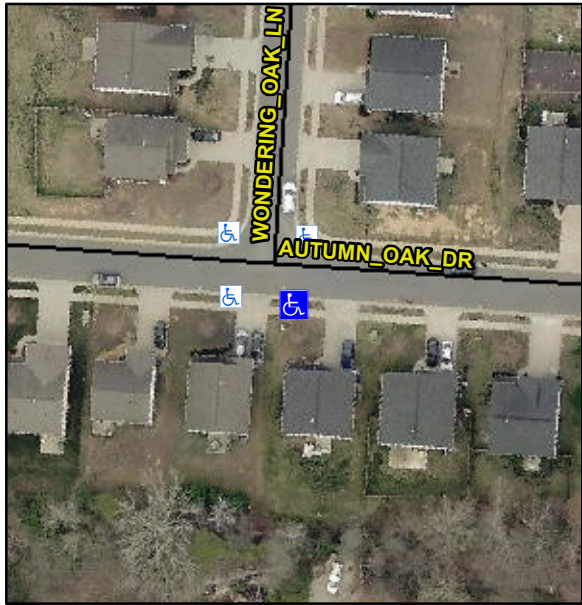
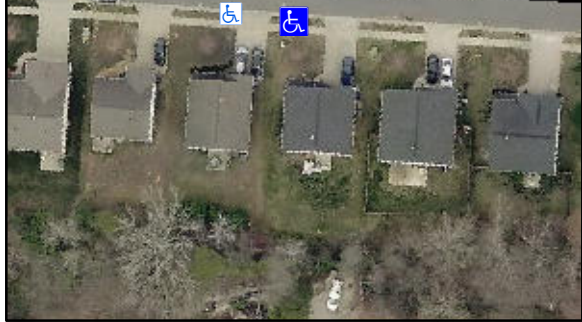
| ADA ID: 643BE5731385 | Ramp Type: Perp | Initial Pass/Fail: Fail | Overall Compliance: No |
| | | | Severity Score: 33.75 |

| Codes/Mitigation Info/Possible Solution | | | Field Measurements/Component Compliance | | | | | |
|---|---|---|---|---|---|---|---|---|
| | Remove & Replace Entire Ramp. | | N/A | Ramp Length (in) | 48.0 | No | Ramp Slope (%) | 17.1 |
| | | | No | Ramp Width (in) | 47.0 | Yes | Ramp XSlope (%) | 1.5 |
| | Not Found, R304.5.1, R304.2.2 | | N/A | Gutter Ponding? | N/A | N/A | Gutter Slope (%) | N/A |

| Codes/Mitigation Info/Possible Solution | | | Field Measurements/Component Compliance | | | | | |
|---|---|---|---|---|---|---|---|---|
| | Possible Solutions: | | Compliance | Description | Data | Compliance | Description | Data |

| Total Cost: | \$ | 1850.00 |
