Access Compliance Report

Public Rights-of-Way

(Curb Ramps)

Intersection ID: 14403	Main Street: ALBEMARLE_RD	Cross Street: ORCHARD_RIDGE_DR	Location: SW
ADA ID: 643CAFFBA3F4	Ramp Type: Perp	Initial Pass/Fail: Fail	Overall Compliance: No
Severity Score: 13.75			
Codes/Mitigation Info/Possible Solution		Field Measurements/Component Compliance

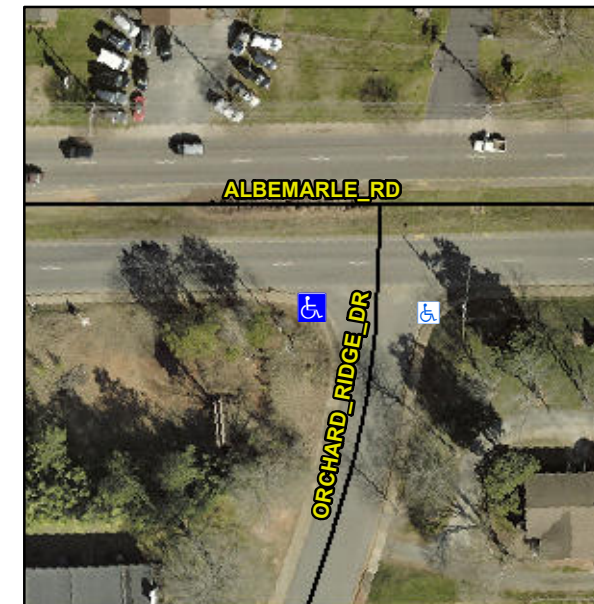
Not Found, R304.2.2, R304.5.3

Compliance	Description	Data	Compliance	Description	Data
N/A	Ramp Length (in)	60.0	No	Ramp Slope (%)	8.5
Yes	Ramp Width (in)	48.0	No	Ramp XSlope (%)	3.4
N/A	Flare Type LT	N/A	N/A	Flare Type RT	N/A
N/A	Flare Slope LT (%)	N/A	N/A	Flare Slope RT (%)	N/A
N/A	Flare Traversable LT?	N/A	N/A	Flare Traversable RT?	N/A
N/A	Landing Length (in)	N/A	N/A	DWS Provided?	N/A
N/A	Landing Width (in)	N/A	N/A	DWS Contrast?	N/A
N/A	Landing Slope (%)	N/A	N/A	DWS Length (in)	N/A
N/A	Landing X Slope (%)	N/A	N/A	DWS Full Width?	N/A
N/A	Landing Curb? (Y/N)	N/A	N/A	DWS Offset (in)	N/A
N/A	Shared Landing?	N/A			
N/A	Gutter Ponding?	N/A	N/A	Gutter Slope (%)	N/A
N/A	Gutter Lip Ht (in)	1.0	N/A	Gutter X Slope (%)	N/A
N/A	Painted X Walk1?	No	N/A	Painted X Walk2?	N/A
	X Walk 1 Direction	To E		X Walk 2 Direction	N/A
N/A	X Walk 1 Width (in)	N/A	N/A	X Walk 2 Width (in)	N/A
	X Walk 1 Slope (%)	1.0		X Walk 2 Slope (%)	N/A
	X Walk 1 X Slope (%)	3.4		X Walk 2 X Slope (%)	N/A

N/A	Ramp inside XWalk1?	N/A	N/A	Ramp inside XWalk2?	N/A
	Road Slope (%)	N/A	N/A	Clear Space?	N/A
	Road X Slope (%)	N/A	N/A	Clear Space to XWalk (in)	N/A
N/A	Any Obstructions?	N/A	N/A	Storm Grate/Utility Hazard?	N/A
	Obstruction Type			Storm Grate/Utility Type	
		N/A			N/A
			Yes	Surface Condition? (G/P)	Good

Possible Solutions:

Remove & Replace Entire Ramp.
