Access Compliance Report

Public Rights-of-Way

(Curb Ramps)

Intersection ID: 7710	Main Street: MONTANA_DR	Cross Street: SENIOR_DR	Location:	N
ADA ID: 643DC6DA6ED8	Ramp Type: Perp	Initial Pass/Fail: Fail	Overall Compliance: No	Severity Score: 33.75

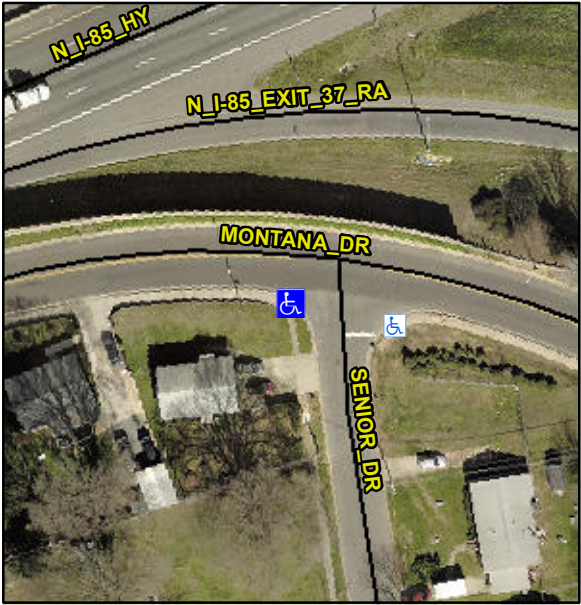
Possible Solutions:		Compliance	Description	Data
	Remove & Replace Entire Ramp.		N/A	Ramp Length (in)	79.0
			No	Ramp Width (in)	36.0
			N/A	Flare Type LT	N/A
			N/A	Flare Slope LT (%)	N/A
			N/A	Flare Traversable LT?	N/A
			N/A	Landing Length (in)	N/A
			N/A	Landing Width (in)	N/A
			N/A	Landing Slope (%)	N/A
			N/A	Landing X Slope (%)	N/A
<p>Surveyor Notes:</p> <p>N/A</p> <p>PROW/ADA:</p> <p>R304.5.1, R304.5.3</p>			N/A	Flare Type RT	N/A
			N/A	Flare Slope RT (%)	N/A
			N/A	Flare Traversable RT?	N/A
			N/A	DWS Provided?	N/A
			N/A	DWS Contrast?	N/A
			N/A	DWS Length (in)	N/A
			N/A	DWS Full Width?	N/A
			N/A	DWS Offset (in)	N/A
			N/A	Shared Landing?	N/A
			N/A	Gutter Ponding?	N/A
			N/A	Gutter Lip Ht (in)	N/A
			N/A	Painted X Walk1?	No
				X Walk 1 Direction	To SE
			N/A	X Walk 1 Width (in)	N/A
				X Walk 1 Slope (%)	4.6
				X Walk 1 X Slope (%)	9.9

N/A	Ramp inside XWalk1?	N/A
				Road Slope (%)	N/A
				Road X Slope (%)	N/A
			N/A	Any Obstructions?	N/A
				Obstruction Type	
Total Cost:		\$ 1850.00			
			N/A		N/A
			Yes	Surface Condition? (G/P)	Good
